DOCKET NO. SA-517
EXHIBIT NO. 7A

STRUCTURES GROUP CHAIRMAN'S FACTUAL REPORT

A. ACCIDENT DCA-97-MA-058

Location: Agana, Guam
Date: August 6, 1997
Time: 0142 Guam Local Time
Aircraft: Boeing 747-300, HL-7468, Korean Air, Flight No. 801

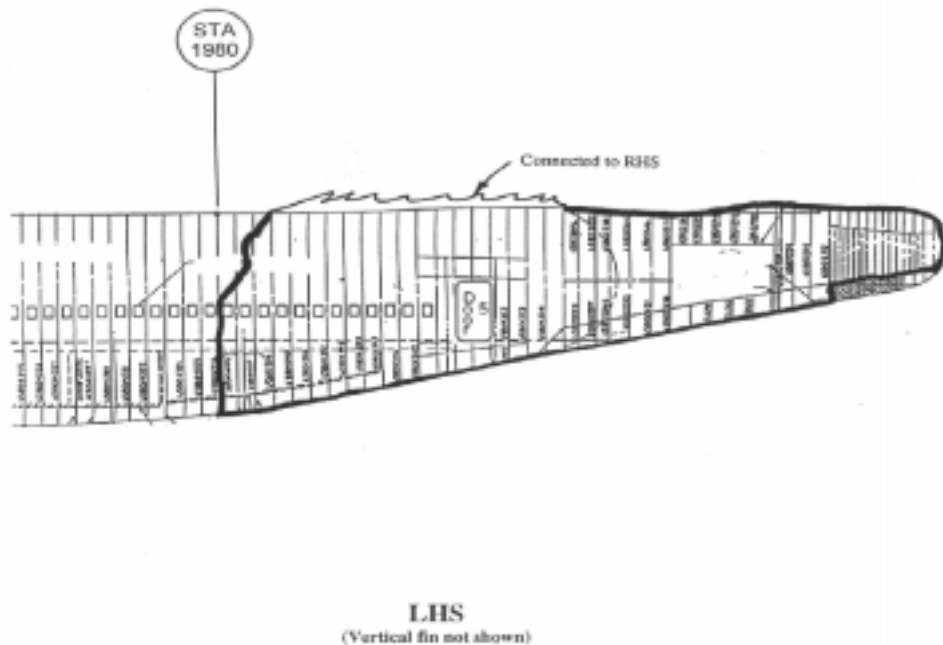
Figure 1

The empennage structure and the aft portion of the section 46 fuselage structure remained attached and essentially intact forward to approximately STA 1980. The RHS and LHS horizontal stabilizer components (including elevators) and the vertical fin were still intact and attached. This entire section was in an upright position and tilted slightly to the LHS. See [Figure 1] and [Figure 2] for a definition of this section.

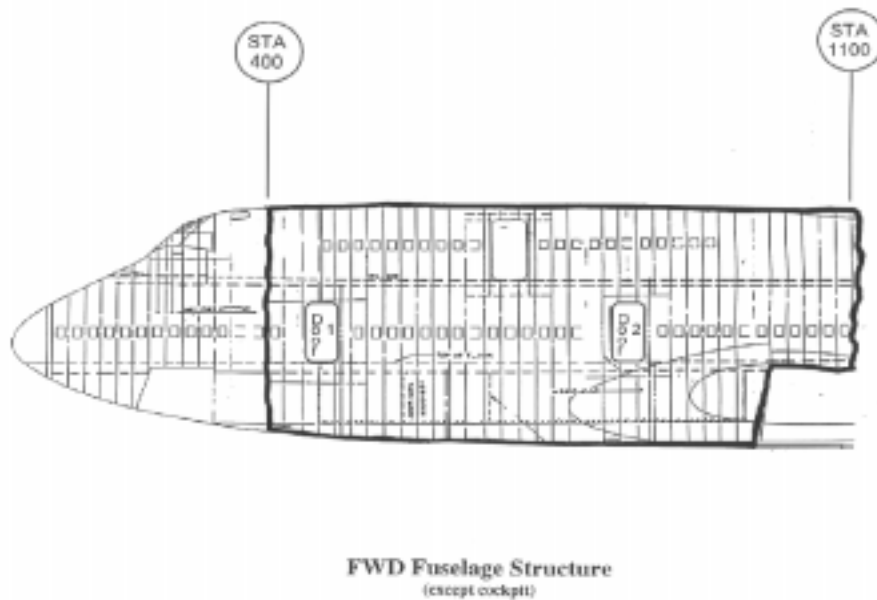
Figure 6

The forward fuselage section from approximately STA 1120 to STA 400 was located on a hillside just beyond the center section (toward the runway). The structure was split just above the main deck floor on the RHS and most of the internal structure (frames, stringers, and fractured floor beams) remained attached. There was extensive fire damage to the structure that was on the lower portion of the hillside (LHS structure and crown area). Much of the structure in this lower area was burned through. There was minimal fire damage to the structure at the top of the hillside (LHS main deck structure). See [Figure 6] for a definition of this section.

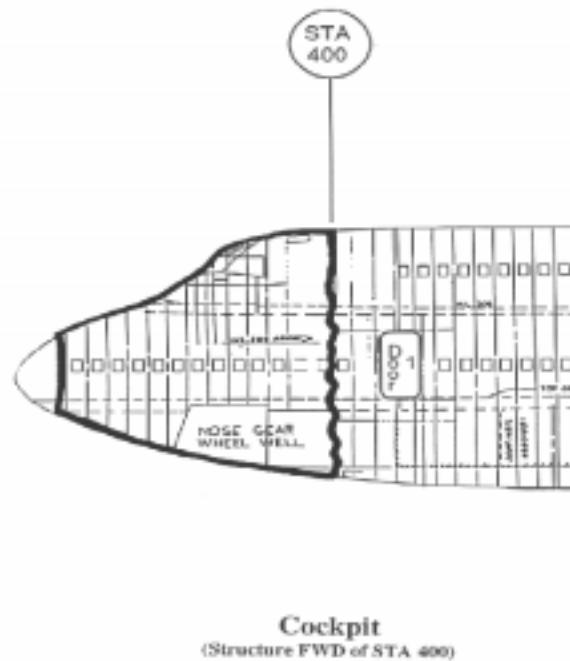
Figure 7

The forward portion of section 41 was located down an embankment beyond the large portion of the forward fuselage. The section was found separated primarily at the STA 400 skin splice and included the cockpit and nose wheel well. The majority of the aft nose wheel well doghouse structure (where the nose gear attaches) was essentially intact with the trunnion support fittings, drag brace fittings, and transverse beam still attached. The gear trunnion barrel and linkage above the trunnion barrel was intact and in the extended position. There was no evidence of fire damage. See [Figure 7] for a definition of this section.

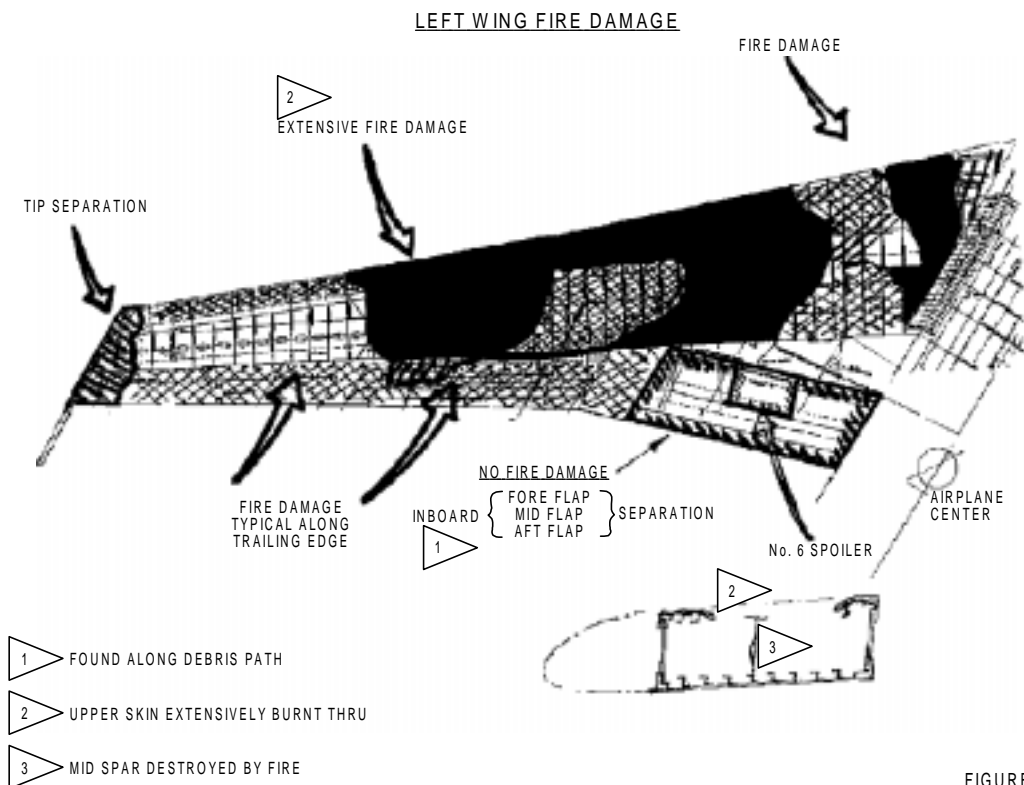
LEFT WING STRUCTURE SEPARATION

The LHS wing outboard section was located approximately parallel to the RHS wing section within the main wreckage area. This wing structure was approximately 80% complete. Extensive post impact fire resulted in heavy damage to the wing upper skin and mid spar between wing station (WS) 470 and WS 1200, including the mid-spar web and chord structure. The corresponding lower skin and stringers also had considerable fire damage. Exposure to the post impact fire resulted in various degrees of damage to the remaining wing structure, including the leading edge and trailing edge flap structure. The outboard wing tip, which was comprised of

The trailing edge flaps and control surfaces were found mostly intact with some local fire damage, with the exception of the inboard flap system, #4 flap track, and #6 spoiler, which separated from the wing box during initial impact (The #4 flap track was located in the debris path prior to the main wreckage area. See wreckage plots and data table [Attachment 1] for location of these components). Examination of these components showed that the fractures typical of overload, resulting from impact. Details of the LHS wing damage are shown in [Figure 9] and [Figure 11].

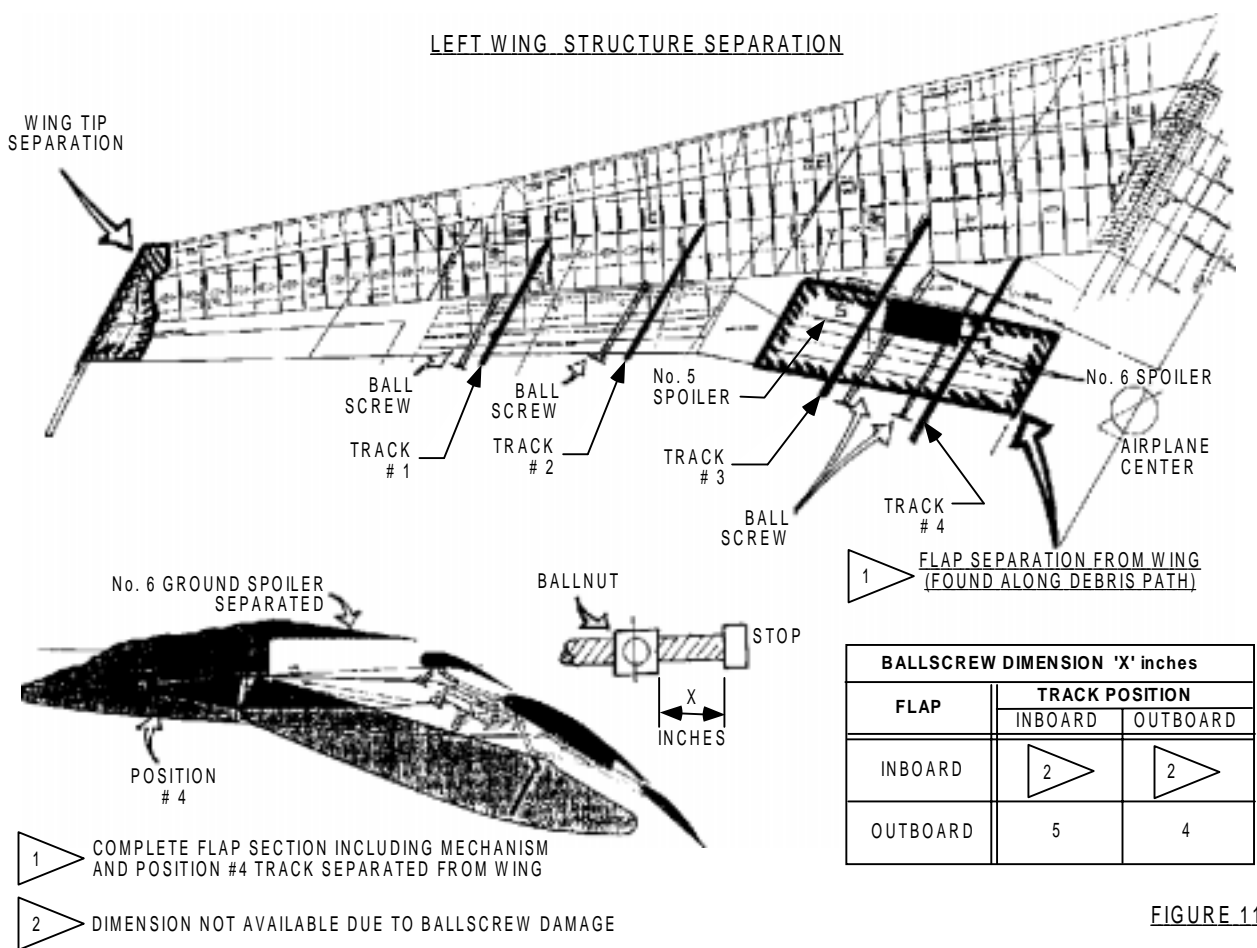
FIGURE 11

The full combination of outboard flap and support structure was found in place on the wing box with a detent extension representative of approximately 25 degrees, as indicated by the measured ball screw position (see Figure 11). The flap structure had heavy fire damage.

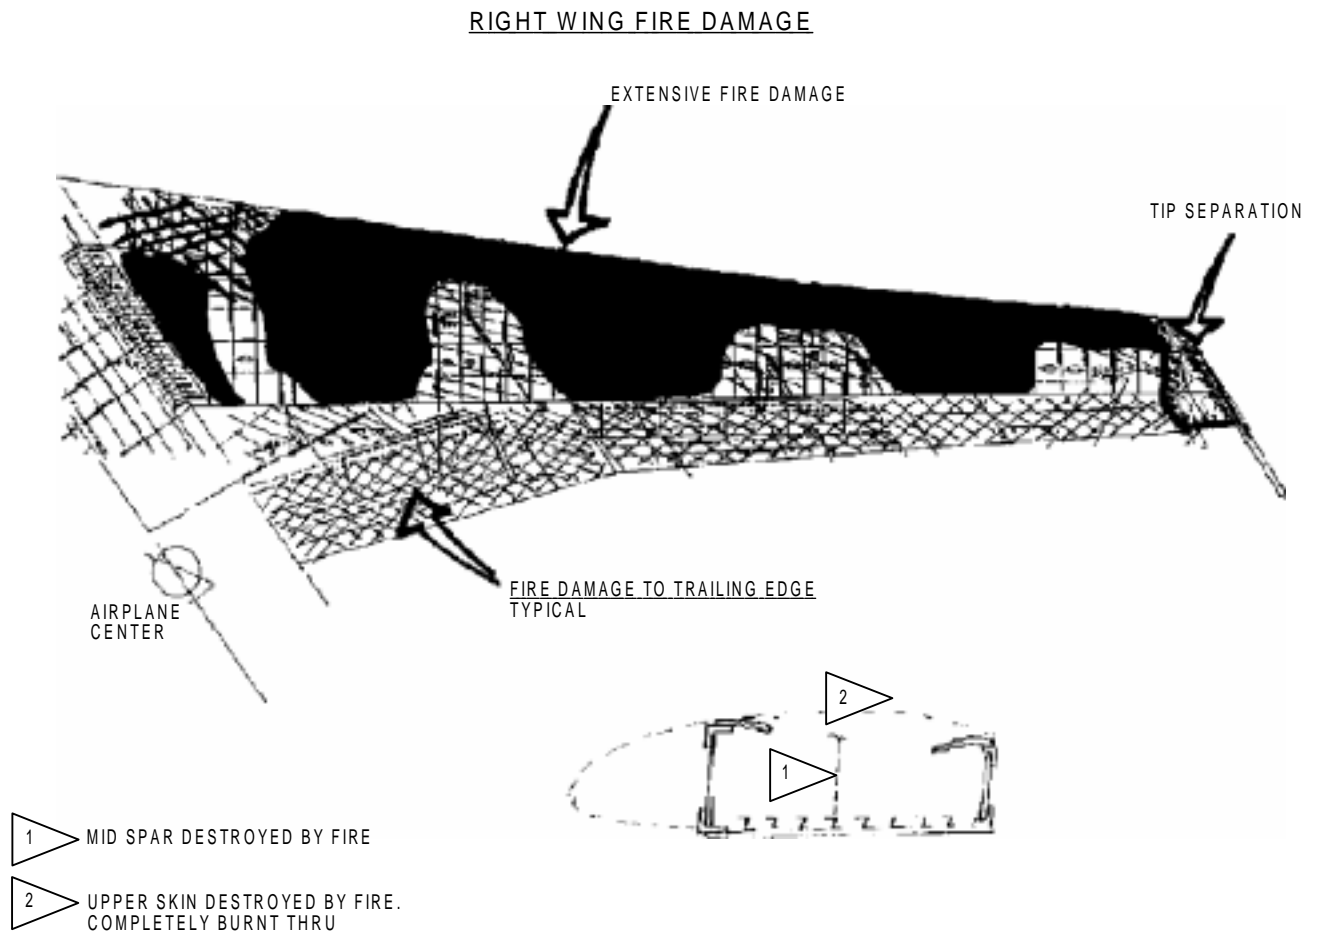
FIGURE 10

The RHS outboard wing section was located alongside the LHS wing within the main wreckage area, with similar damage to the wing box structure as a result of impact forces and post impact fire damage. The wing structure was approximately 75% complete with extensive fire damage between of the upper skin and related mid-spar web structure between WS 500 and WS 1400. The outboard wing tip was separated at the surge tank end rib in a similar manner to the LHS wing structure and was free of fire damage.

The full compliment of flight control surfaces and trailing edge flaps remained with the wing box, with the exception of approximately six feet of the inboard end of the fore, mid, and aft flap structure (These components were found in the vicinity of the initial impact. See wreckage plots and data table [Attachment 1] for location of these components). The fractures are typical of overload, resultant from impact forces. This section was free of fire damage. Details of the RHS wing damage are shown in [Figure 10] and [Figure 12].

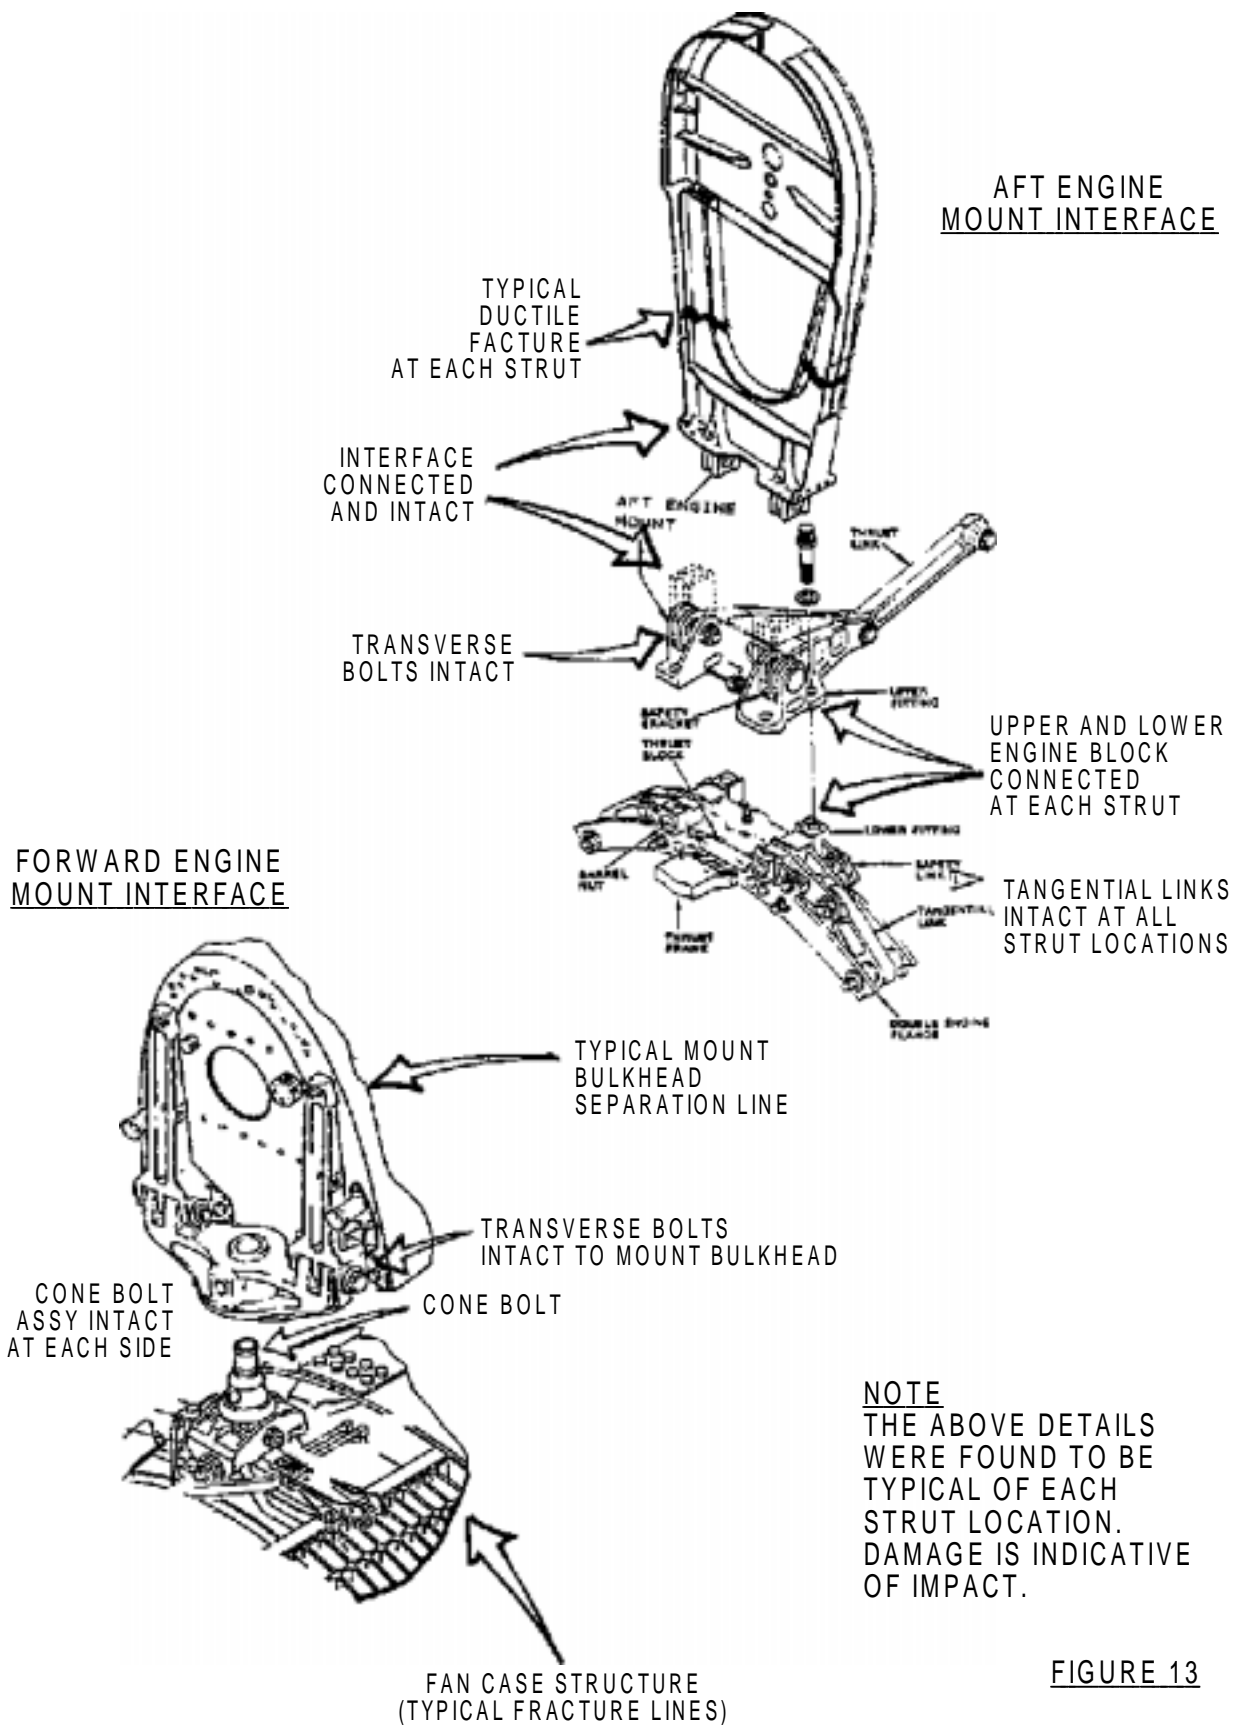
FIGURE 13

All four P&W JT9D-7R4G2 engines were found detached from the aircraft. Engines #2, #3, and #4 were located in the main wreckage area. The #1 engine was located close to the initial impact area as shown in [Attachment 1]. Typical engine mount separation is shown in [Figure 13].

Each forward and aft engine mount assembly was located and included the strut forward bulkhead, the cone bolt assembly, and the strut rear engine mount and tangential link assembly. Each of these components were found intact and connected to a section of the fan case and “S” frame segments respectively.

Although the strut and engine frame had extensive impact damage, the primary interface assemblies for both the cone bolt and tangential link assembly of each engine remained intact.
