WBA of the Royal Majesty Accident

Derived from NTSB Report NTSB/MAR-97/01

Lars Heidieker, Nils Hoffmann, Peter Husemann, Peter B. Ladkin,
Jan Paller, Jan Sanders, Jörn Stuphorn, Andreas Vangerow

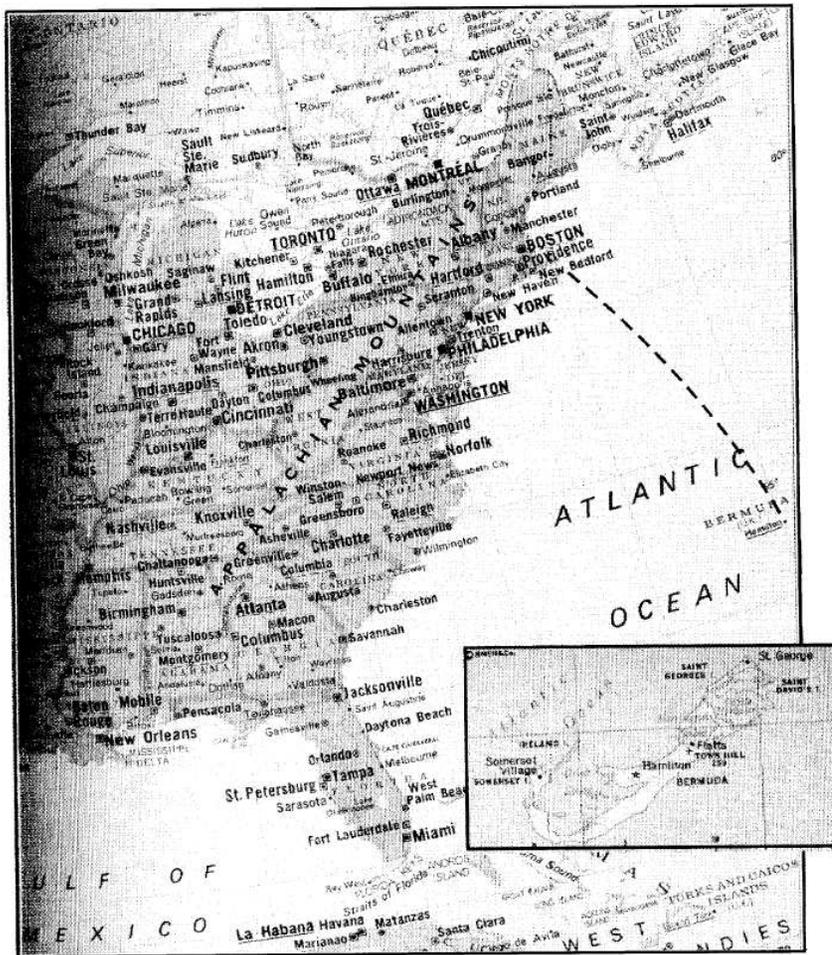
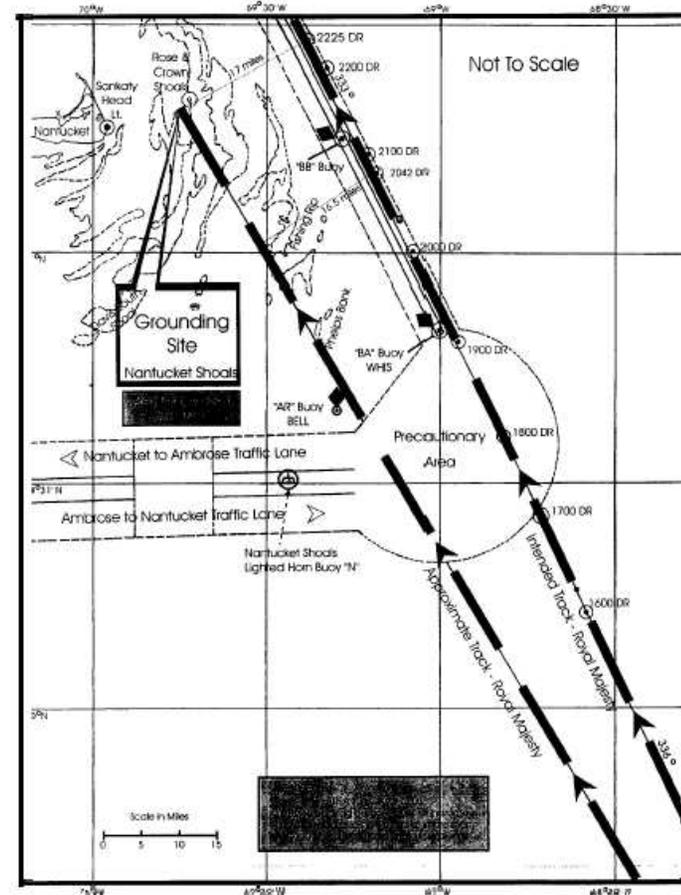
Planned and Actual Course

Figure 5-intended track and approximately actual track.

- Ship ran aground some 34 hours later, at 22:25 on June 10, on the Nantucket shoals, some of the most dangerous water for general shipping in the world, some 17 miles west of course

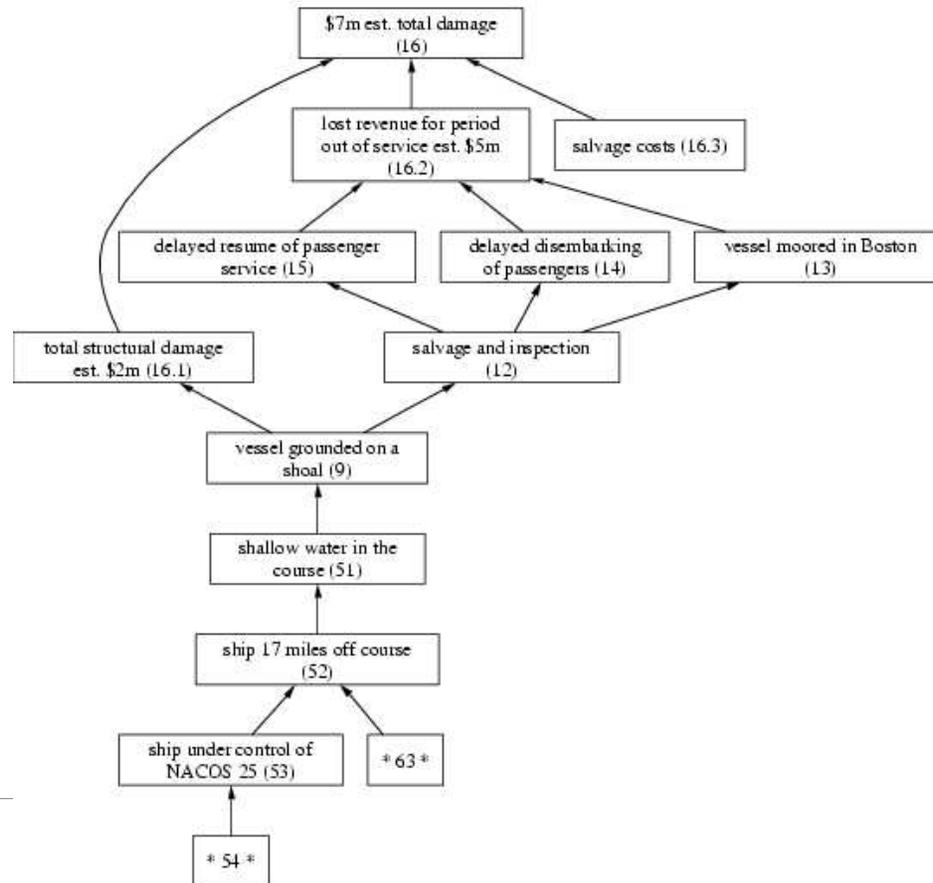
The WBG

- The top level of the WBG is fairly self-explanatory
 - The formal definition of why it was an accident
 - Costs incurred through salvage and loss of revenue
 - The proximate reason why it occurred
 - Ship was off course
 - The proximate reason of the proximate reason
 - Ship was under control of the autopilot
 - Autopilot receiving inappropriate nav data

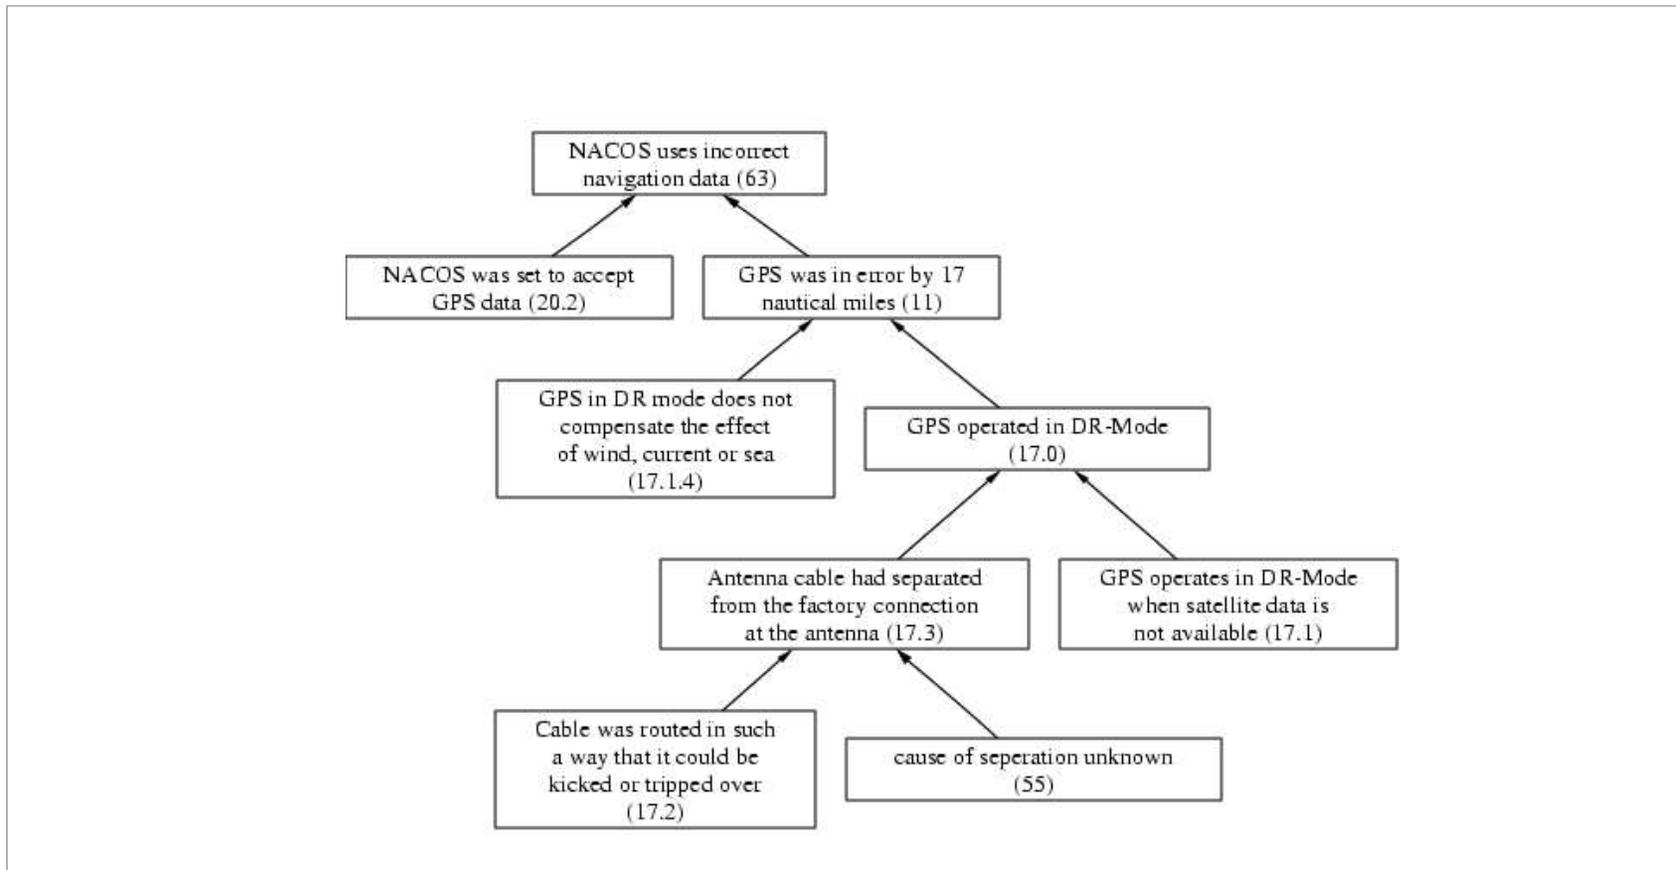
The WBG, Subgraph from Node 63

- Also mostly self-explanatory
 - The autopilot was getting inappropriate data because it was listening to GPS and GPS data was faulty
 - Note that the failure to check by the crew does not appear here. Should it?
- GPS data was faulty because GPS was operating in dead reckoning mode and this mode does not compensate for various physical effects (wind, current, sea)
 - It is presumed that such effects pertained. In any case, that the dead reckoning data were so far off the actual position was not felt to need further explanation.

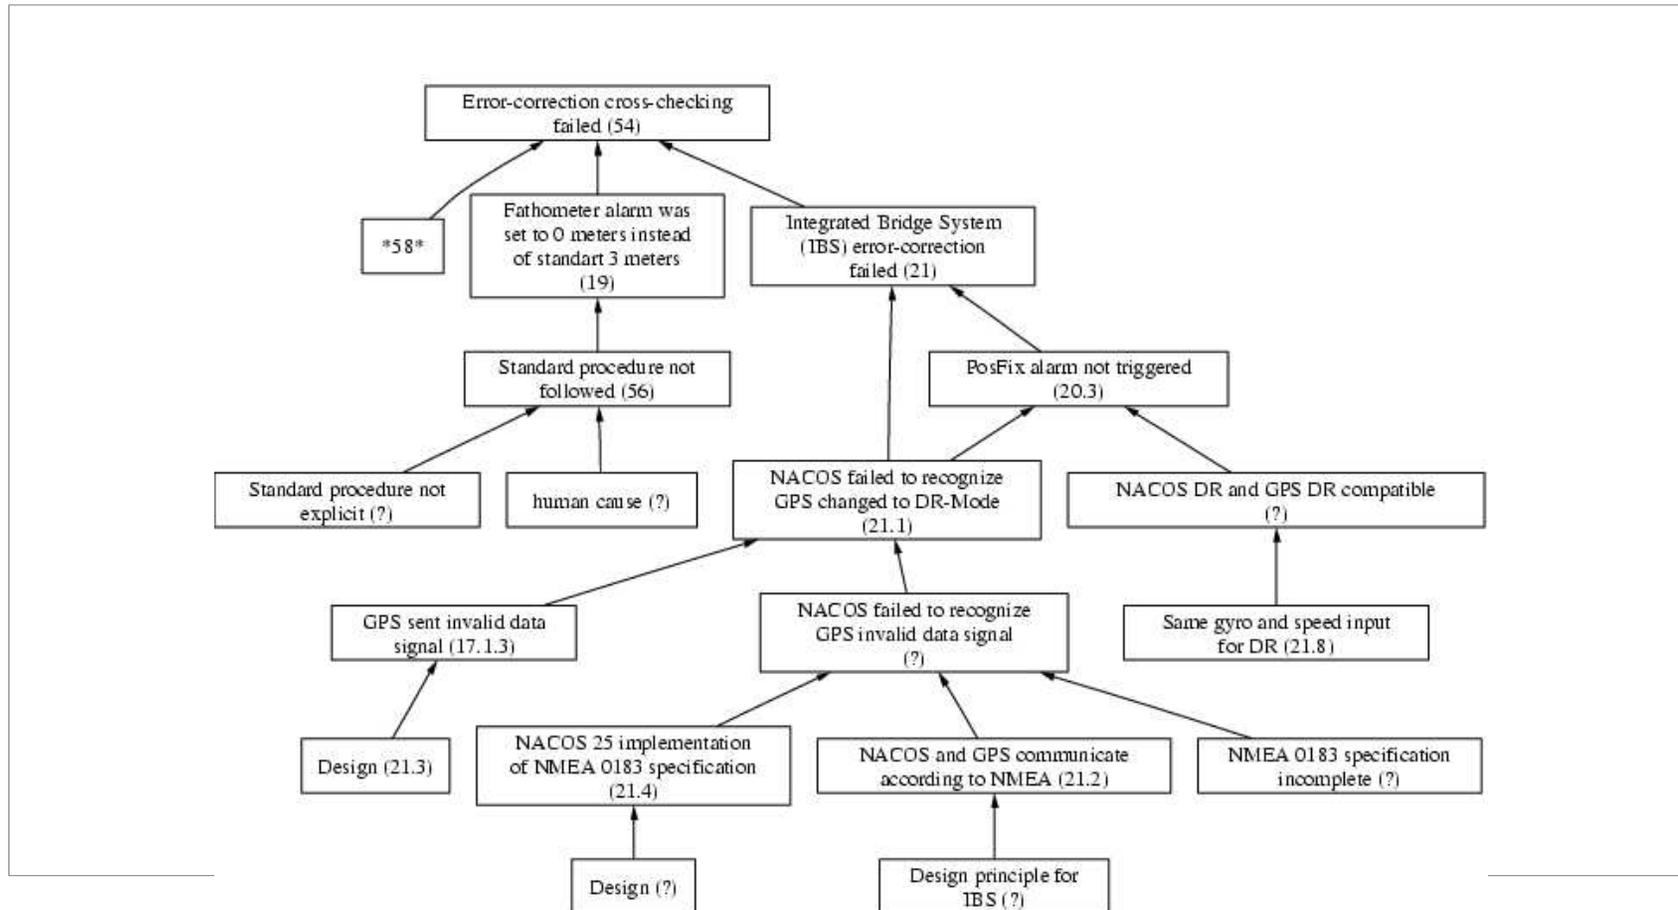
The WBG Subgraph from Node 54

- The error cross-checking is both human-operator and digital
 - They involve separate mechanisms so are split
- The digital checks failed because the NACOS 25 and GPS were not communicating compatibly
 - GPS was sending data and signalling invalidity on special bits according to specification NMEA 0183
 - NACOS 25 was not listening to those bits
 - It was expected „bad data“ to mean: no data, or nulled data fields, or constant data
 - The NMEA 0183 specification apparently allowed this situation to pertain

- The fathometer alarm was left at 0m (the setting for port, to prevent nuisance alarms) and not set to the under-way value of 3m
 - Had it been so, the ship would have had plenty of warning that it was entering shallow water, instead of being in the deep channel
 - The NTSB believes this warning would have been sufficient to avoid the grounding
- There was also a failure of traditional seamanship and of human cross-checking of the automation (Node 58)

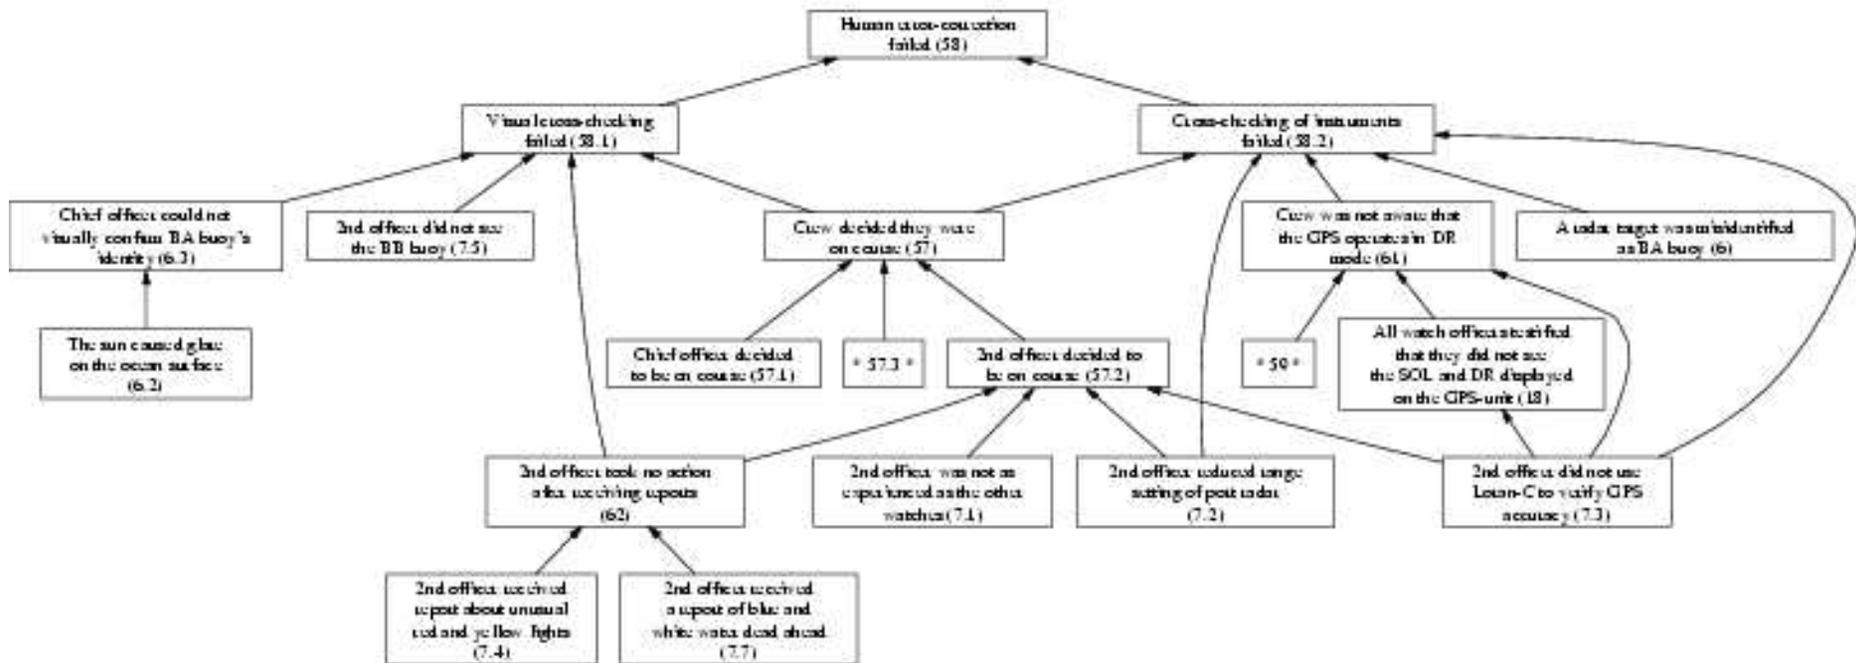
The WBG Subgraph from Node 58

- Two specific actions of the 2nd officer seem to have significant causal effect on a lot of nodes
- How the 2nd officer decided they were on course receives a lot of attention. However, how the chief officer decided they were on course does not appear to be further investigated
 - The 2nd officer was the watch officer at the time of the grounding
 - It may have to do with the fact that the NTSB decided the 2nd officer was lying:
 - he cannot have seen any buoy which could have corresponded to the BB buoy, which he reported as having passed.
 - He claimed to have checked the GPS (against Loran) and found it „on track“

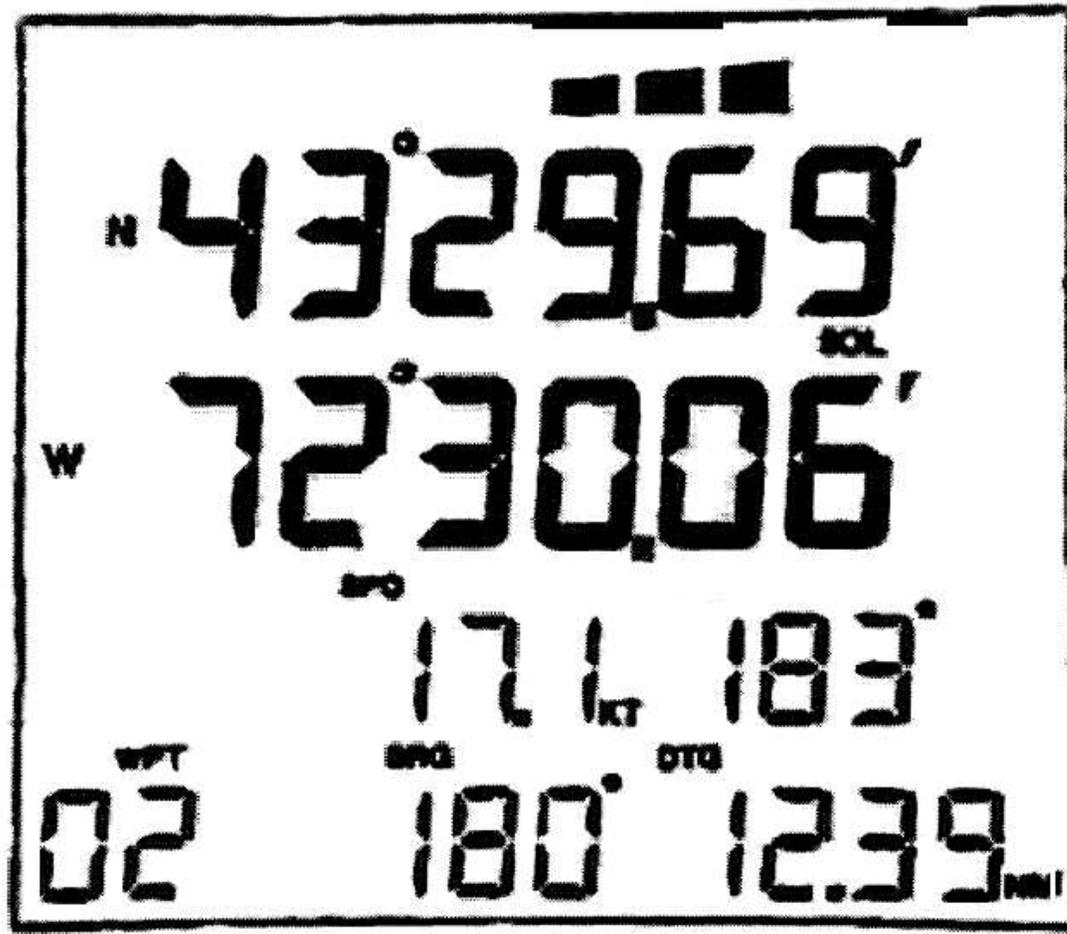
The GPS display

- None of the crew was aware that the GPS was operating in DR mode
 - It was in the chart room and the display was out of sight
 - The „DR“ mode indication on the display was tiny
 - The DR mode aural alarm sounds only for a brief time and is in the chart room, not on the bridge central console where the watch officer stands
 - Still, cross-checking against the Loran is required, and was evidently not performed
 - It is presumed the Loran was indicating accurately; the area where they were is very well covered by Loran signals

Figure 8—GPS display showing SOL and DR.

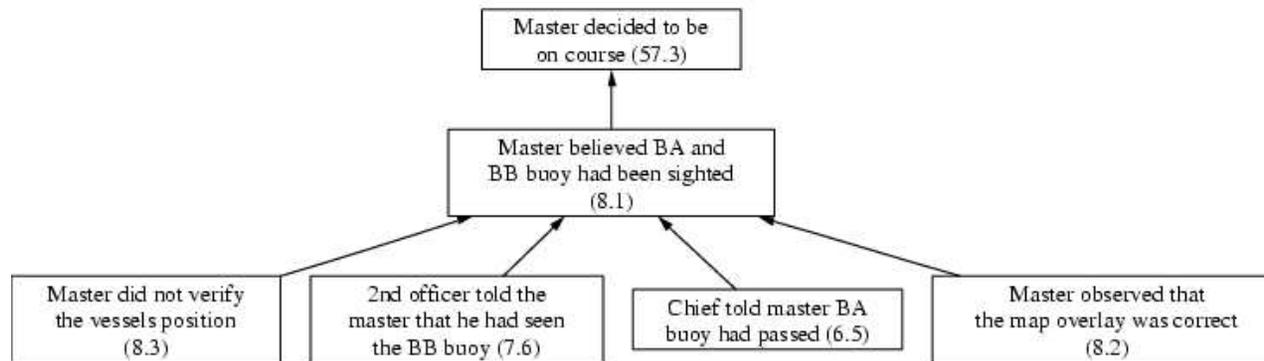
The WBG Subgraph from Node 57.3

- The master just listened to what he was being told by his watch officers
- He did not himself perform anything other than cursory checks
- However, many of the clues that the IBS was not operating as desired were available to him also
 - He had no way of knowing that the buoy sightings were deficient
 - He had no way of knowing of the visual anomalies except through the 2nd officer reporting them, as procedures say he should

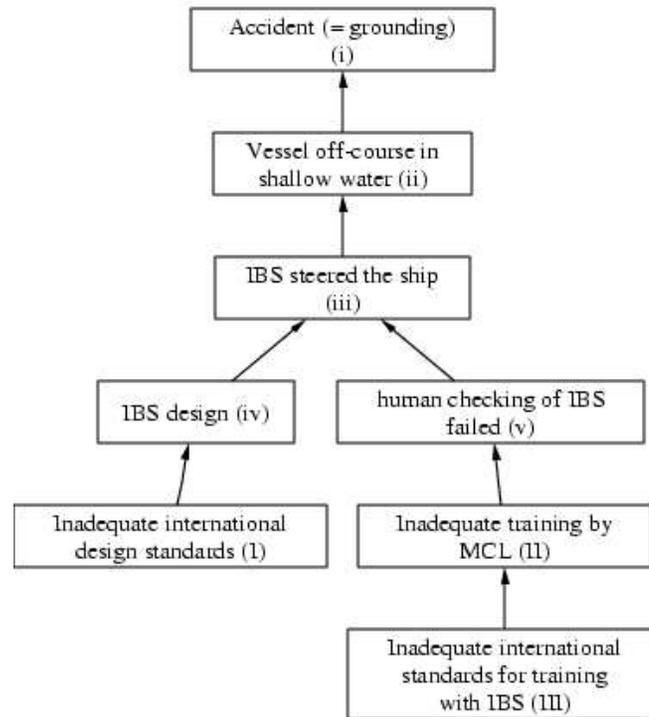
The WBG according to the NTSB

- Some of these nodes appear for the first time here (they are not in the report body; they are not in the Conclusions)
 - It may be appropriate to require that any fact appearing in the Conclusions is contained in the report body (under Analysis, for example)
 - It may be appropriate to require that any fact appearing in the statement of Probable Cause appear in the Conclusions
- Besides that, there is a mistake. A factor is omitted

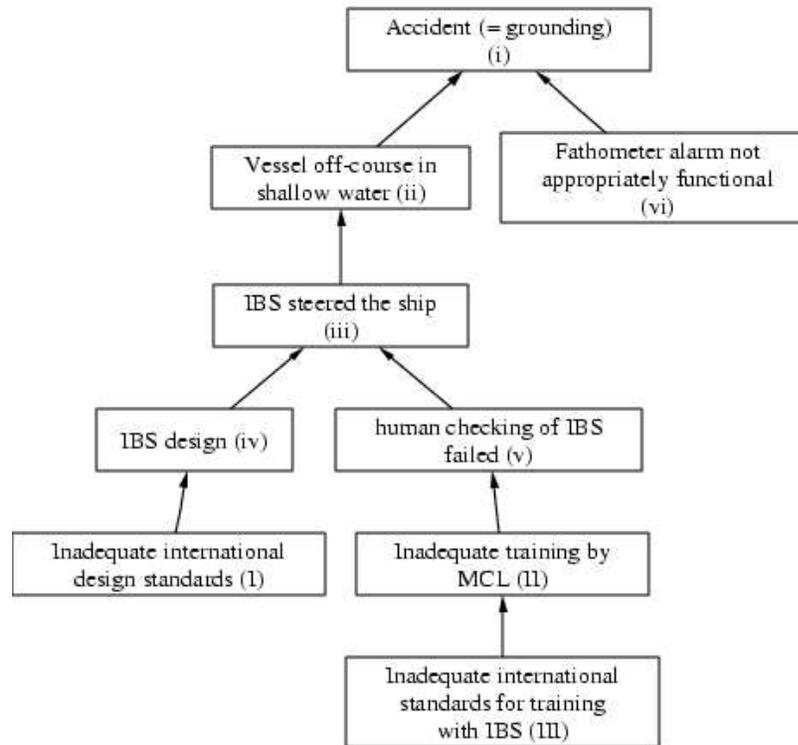
A Plausible WBG Reduction With the Extra Nodes

- That the inappropriate functionality of the fathometer alarm was a causal factor in the grounding is determined directly through the Counterfactual Test
 - Had the alarm been set to 3m, warning would have been given in adequate time to take evasive action
- However, this is not the assertion concerning the fathometer alarm that appears in the report body or Conclusions
 - It appears their positively: it was set to 0m
- Positive and negative formulations of the same „fact“ have different causal relations!
