GABINETE DE PREVENÇÃO E INVESTIGAÇÃO DE ACIDENTES COM AERONAVES

Accident Investigation Final Report

All Engines-out Landing Due to Fuel Exhaustion

**Air Transat
Airbus A330-243 marks C-GITS
Lajes, Azores, Portugal
24 August 2001**

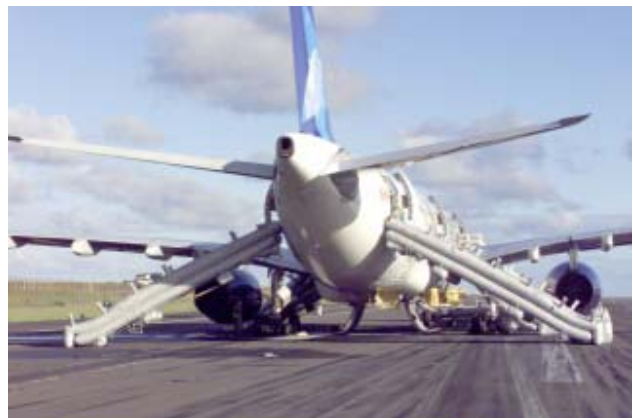
At 06:45, the aircraft crossed the threshold of runway 33 at about 200 knots, touched down hard 1 030 feet down the runway, and bounced back into the air. The second touchdown was at 2 800 feet from the approach end of the runway, and maximum braking was applied. The aircraft came to a stop 7 600 feet from the approach end of the 10 000-foot runway. After the aircraft came to a stop, small fires started in the area of the left main-gear wheels, but these fires were immediately extinguished by the crash rescue response vehicles that were in position for the landing⁶. The Captain ordered an emergency evacuation. Fourteen passengers and two cabin-crew members received minor injuries, and two persons received serious injuries during the emergency evacuation. The aircraft suffered structural damage to the fuselage and to the main landing gear.

Figure 1 - Aircraft After Landing

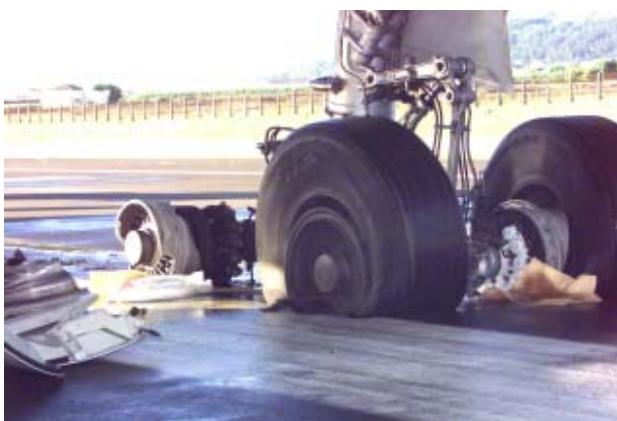
Due to the engines-out condition, the landing was conducted without the brake anti-skid and normal braking systems. Because the emergency brake accumulator only provides for a limited amount of brake applications, full braking was applied and retained at the second touch down, resulting in the main wheels locking up. The tires quickly abraded and deflated at a point between about 300 and 450 feet beyond the second and final touch down. The segments of the main wheels contacting the pavement were worn down to the bearing journals, the left, rear, inboard wheel detached from the axle. Both left and right brake anti-torque links attachment horns on the bottom segments of the main oleos also contacted the pavement; the horns were abraded to the point that some of the links separated from the oleo resulting in the rotation of at least one brake carrier.

Figure 2 - Left-main Boogie

Shedding of brake and wheel components during the landing run also resulted in a combination of punctures and impact damage to the airframe and left engine nacelle.

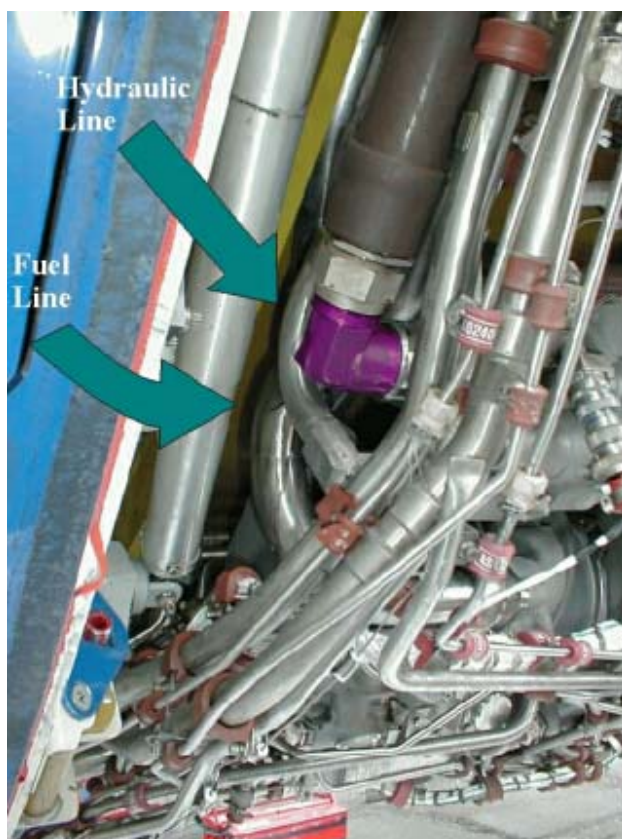
Both reports concluded that the fuel and hydraulic tubes fully matched the drawing characteristics for material, form and shape. The fuel tube wall section was measured and showed that the wear had reduced the wall thickness by 0.005 inches, and that the hard contact had resulted in a dent measuring 0.044 inches deep. The examination concluded that the fuel tube fractured in high cycle fatigue at multiple initiation sites in the bore and the outside diameter, due to a combination of vibratory stresses being superimposed on the tube deformation. Also noted were some scratches and deep scores around the chafed location on both tubes. Report MFR 41281 stated that these marks are believed to have been made at the time of installation of the engine because this was the only time the post-SB fuel line and pre-SB hydraulic lines were mounted adjacent to one another. The report con-

Figure 3 - Right Engine Pipe Contact

cluded that the scratches and scores were directionally aligned and that they could have been caused from repeated contact from a blunt instrument, such as a screwdriver being inserted between the tubes in order to force a clearance between them. There were no cracks initiated from the score or scratch marks.

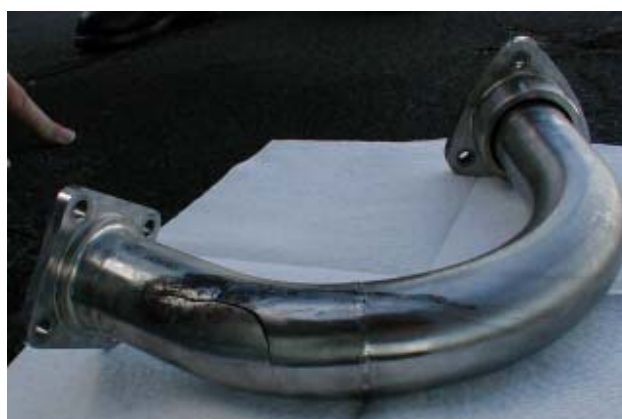
The initial inspection of the right engine following the occurrence uncovered the presence of an L-shaped crack on the inlet fuel tube wall (Part No FK30383). The crack was approximately 3.0 inches (80mm) long, and was spread to a width of about 1/8 inches (2.5mm). In addition, the hydraulic outlet tube (pressure) for the rear hydraulic pump was found to be in hard contact with the fuel tube. The cracking on the fuel tube extended to both sides of a mechanically worn (chafed) area where the tubes came into contact. It was evident that the interference and chafing occurred due to the mismatched installation of the post-mod fuel tube (P/N: FK30383) and pre-mod hydraulic tube (P/N: LJ51006). Based on the DFDR data, it was determined that the fuel leak rate through this cracked reached a maximum of about 13.0 metric tons per hour.

Figure 4 Fuel Pipe Crack & Scratches

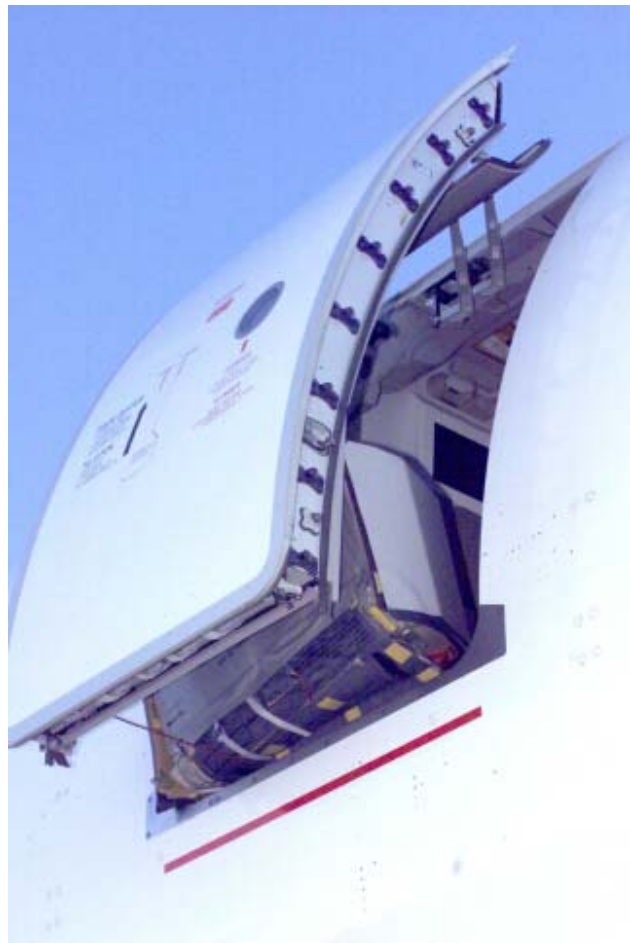
Sometime after the landing, fire-rescue crews, in attempting to eliminate the hazard of the escape slide inflating within the cabin, used a pry-tool to release the slide and open the door. Reportedly, when the door was opened, the slide fell out the door and only inflated partially.

Figure 6 - Door L3 Jammed

Inspection of the L3 exit did not reveal any damage to the door or frame, other than minor scratches and minor damage to the plastic panel in the area where the pry bar was used. When operated by investigators, the door opened and closed without any restriction and no mechanical distortion or malfunction was found either with the arming system or with the locking/unlocking of the girt bar. An examination of the power-assist unit indicated that it had been activated.

Conclusive finding as to the cause of the door jam could not be made, primarily because of the missing components. Notwithstanding, interviews and photos confirm that the slide had not released completely from the door, and that the bustle rails/rail adapters may have jammed.
