Technical report A-006/2001

Accident of aircraft Airbus
A-320-214, registration
EC-HKJ, at Bilbao Airport
on 7 February 2001

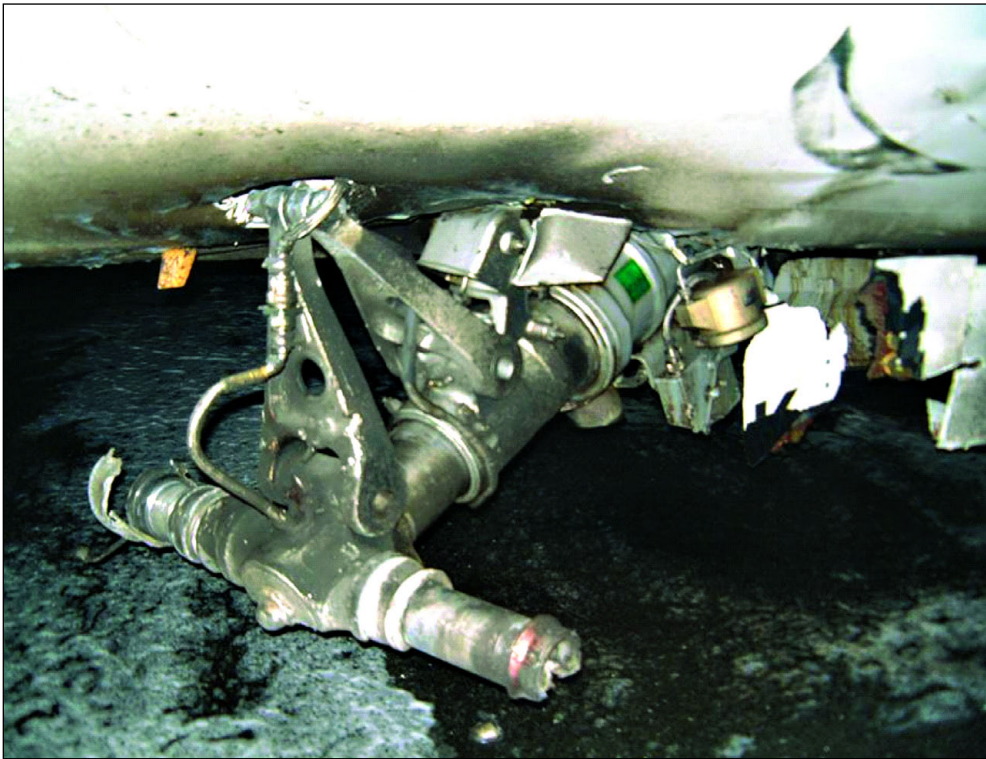
All four main gear wheels burst. The gear doors suffered several points of damage.

Structural damage was indicated by the deformation of a frame at the front part of the airframe.

It was suspected that during the event important structural damages could have occurred due to the high load factor achieved, 4.75 g according to the DFDR. Subsequent internal damage assessment, led to consider the damage beyond economically viable repair and therefore the aircraft was written off.

Collapsed nose gear detail

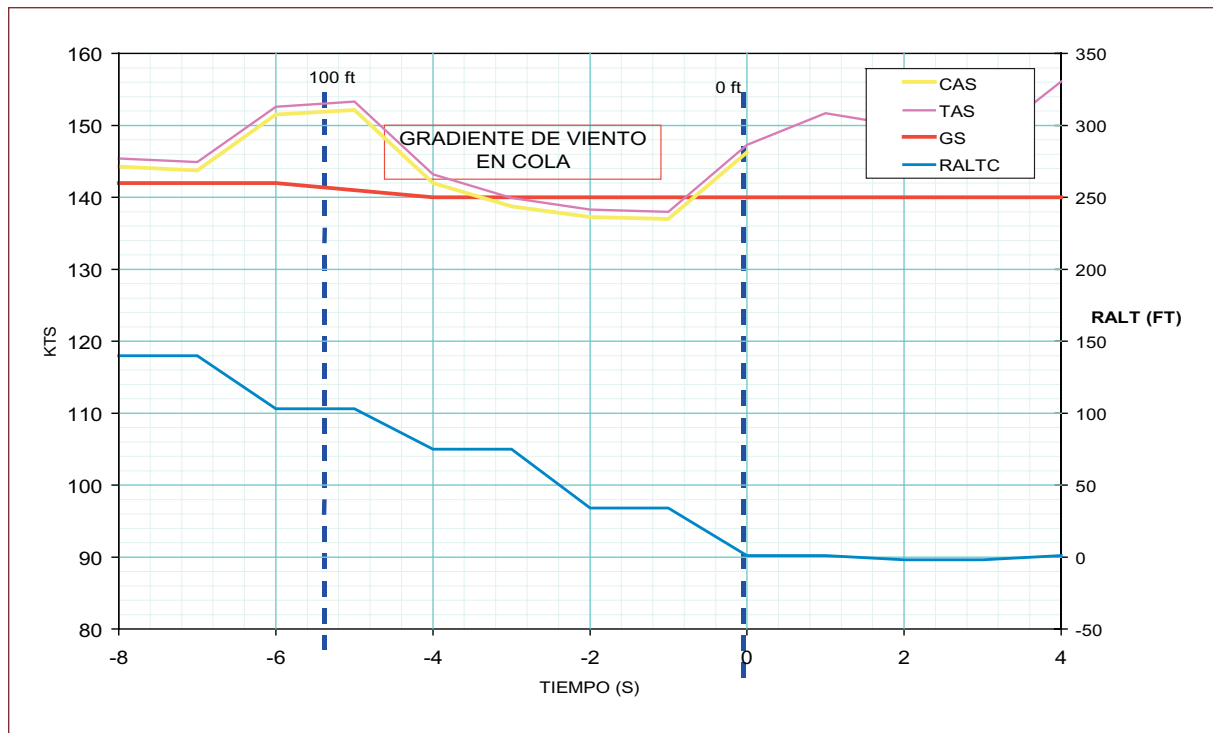
When the aircraft found the updraft, the pilot flying pushed his sidestick, and afterwards he pulled it when he entered the down-draft.

Figure 2.1.1. Speed changes during the last seconds

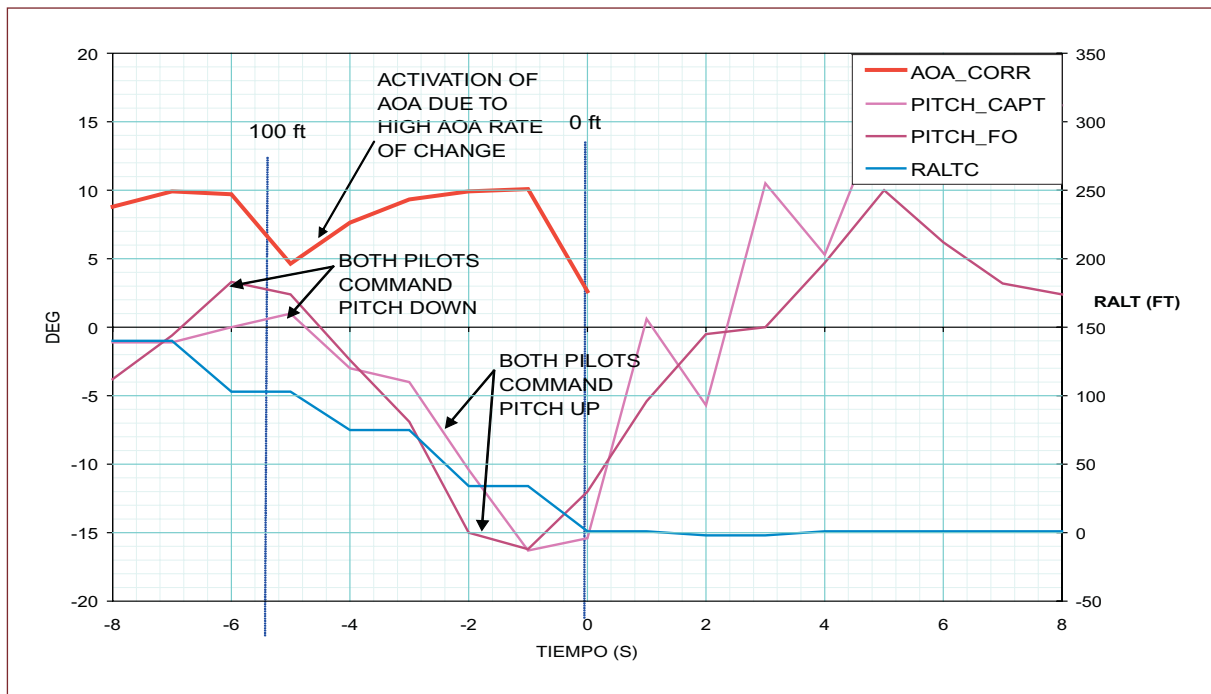
The captain also pulled his sidestick backwards, adding his input to the co-pilot's. The sum of both inputs soon exceeded 10° of nose-up sidestick position. Under that situation, the logic of the EFCS system gave complete priority to the term of the rate of change of AOA anticipating a high and dangerous AOA, close to stall.

The rapid increase of the AOA, together with both sidestick inputs, caused the activation of the AOA protection.

The AOA protection status remained active down to runway touch-down because the sidestick pull input was never released and the software logical conditions to deactivate it were never met.

The AOA protection activation was followed by a tail-wind gradient that produced a reduction in the airspeed. This reduction could have been interpreted by the EFCS automatism as a phugoid movement, which would have resulted in an automatic nose down input just as the aircraft hit the runway.

Figure 2.1.2. Change of AOA and sidestick actions of the pilots

Airbus Industrie developed a new standard for the ELAC, standard L81, to modify the logic in the AOA protection in case of turbulent conditions. The new standard was certified by mid 2001, and the corresponding Service Bulletin was published in September 2001. The software modification, considered mandatory by the aeronautical

Below 200 ft a de-activation condition is added to cancel the AOA protection. The AOA protection is also deactivated when the sidestick is between its neutral position and «-8° nose up” with $\alpha < \alpha_{\text{prot}} - 2$ (ALPHA < ALPHA PROT-2 degrees).

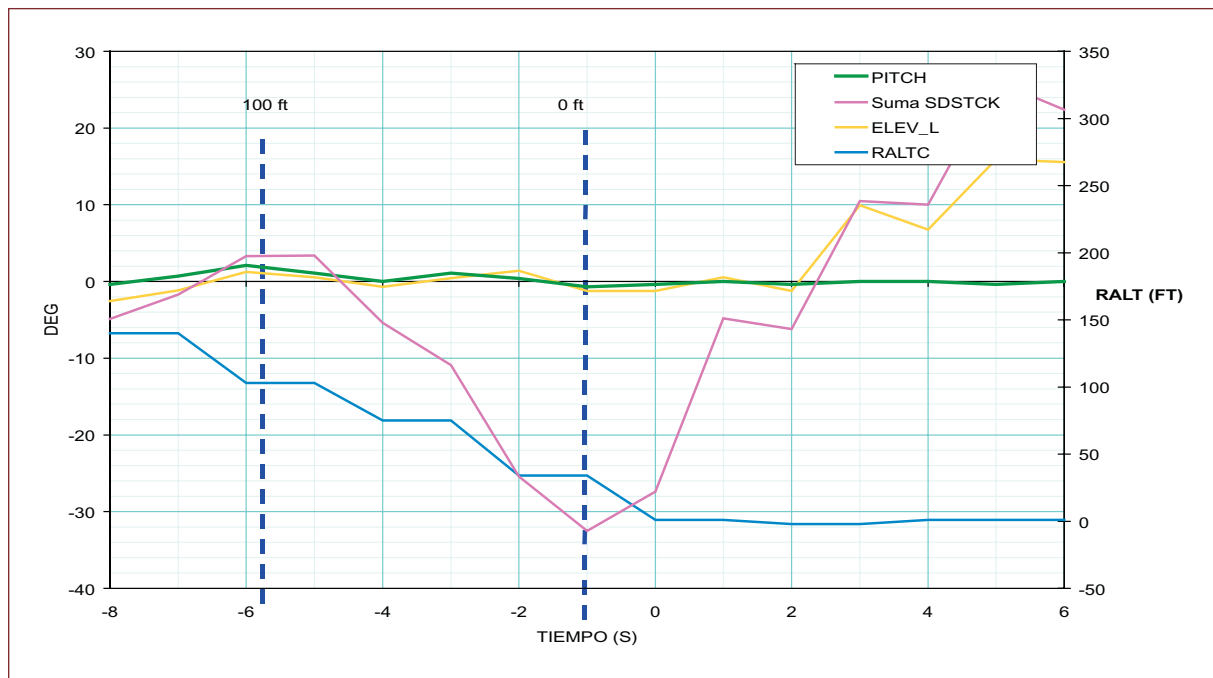
Under these wind conditions and with the sidestick actions described above, the response of the aeroplane is coherent with the logic of the flight controls system described in paragraph 1.6.6 that corresponds to the ELAC standard 80.

The accident made it evident that the logic of the AOA protection activation, with an anticipation term of the angle of attack, valid and appropriate in other phases of the flight, is not appropriate in the phase of short final approach.

Figure 2.1.3. Response of the aircraft to the sidestick movement: Deflection of the LH elevator and changes in pitch angle

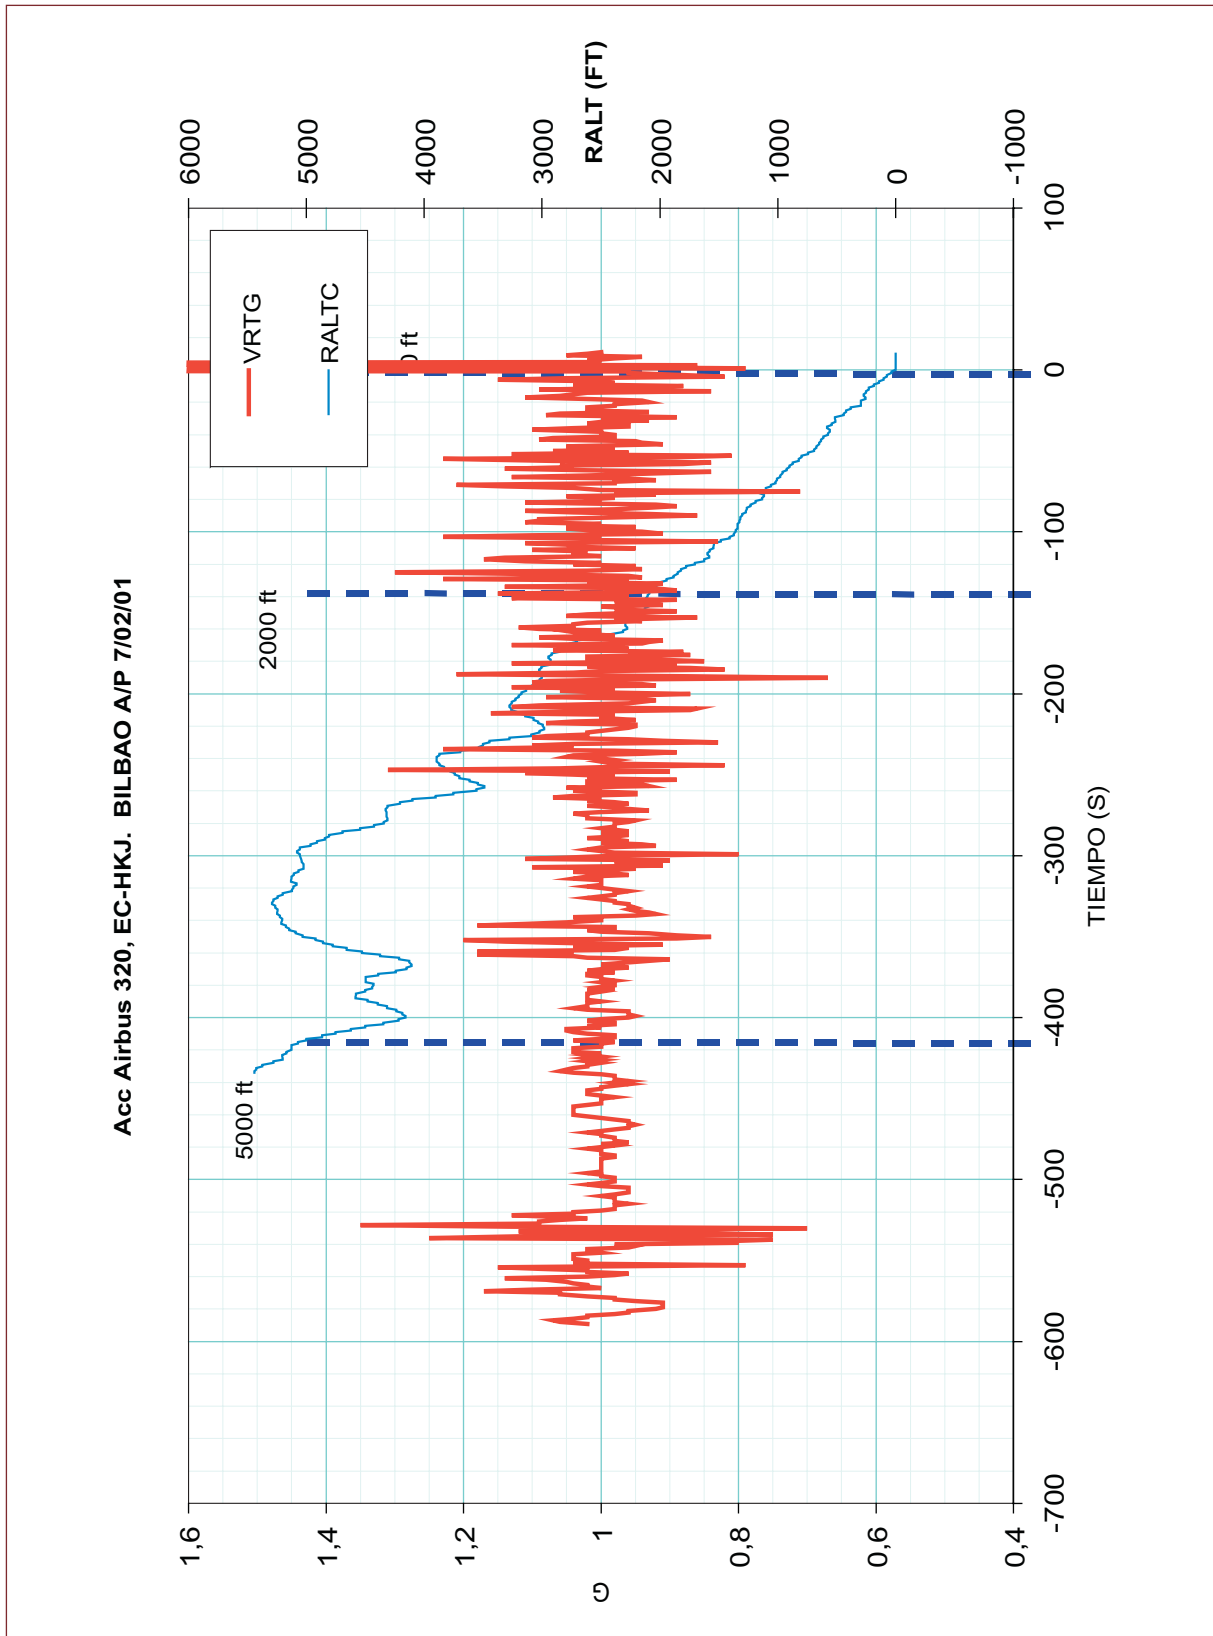
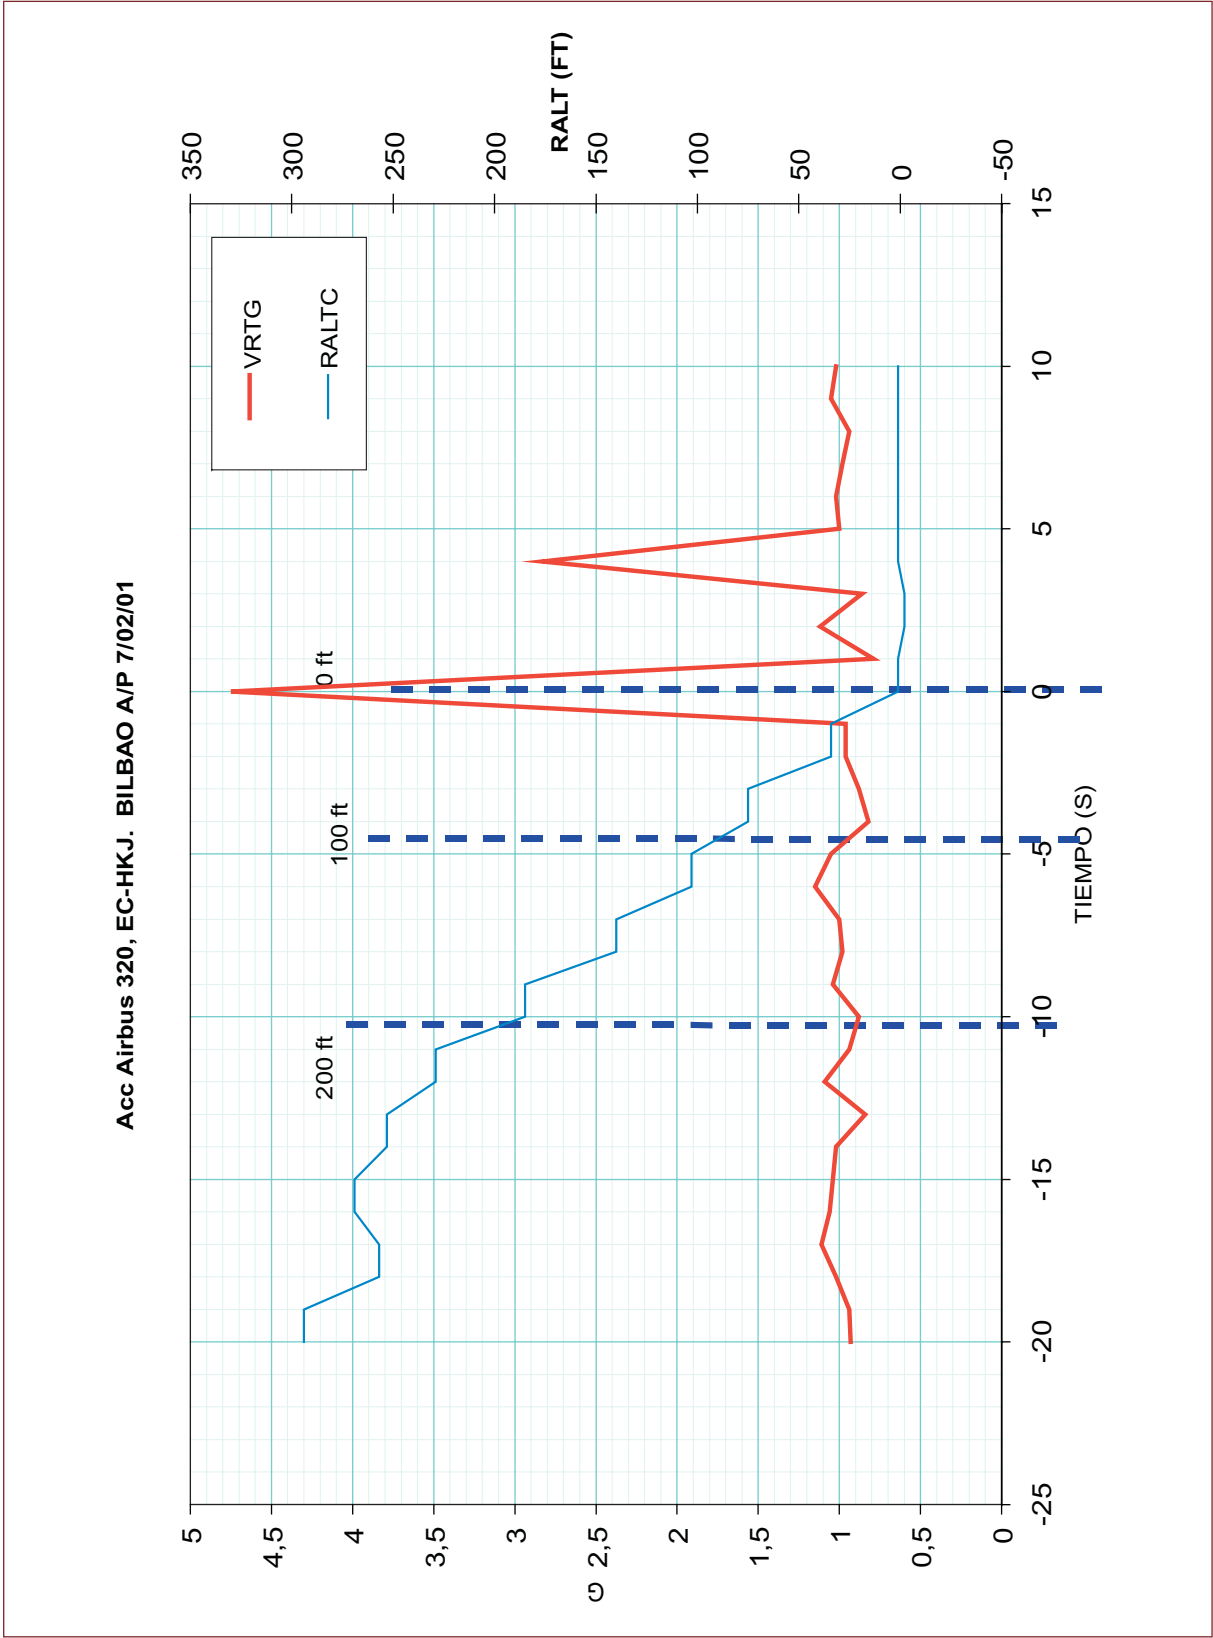
In the approach airspace there was turbulence as evidenced by the recorded vertical acceleration between 0.7 and 1.35 g (see graphs 1 and 2 in Appendix A). Weather conditions were the typical ones usually associated with mountain wave rotors.

Figure 1. Vertical acceleration records

Figure 2. Vertical acceleration records (continued)

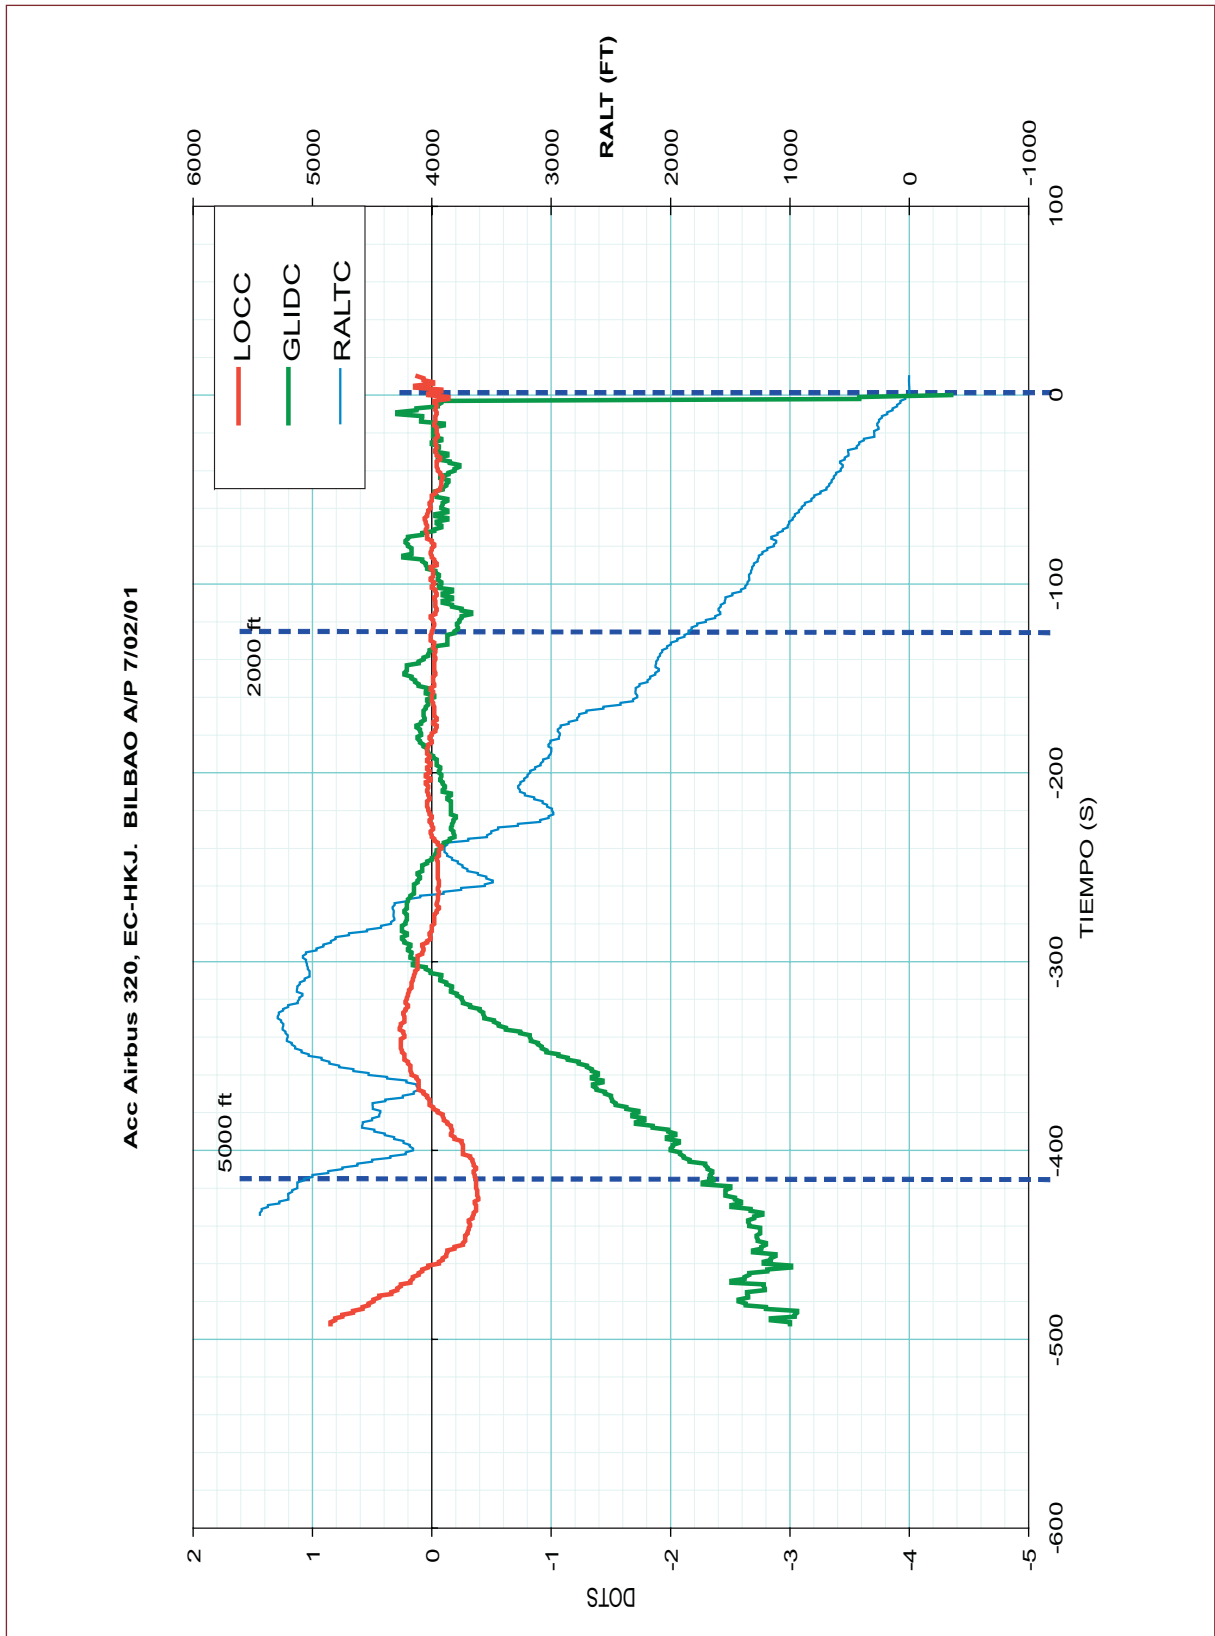
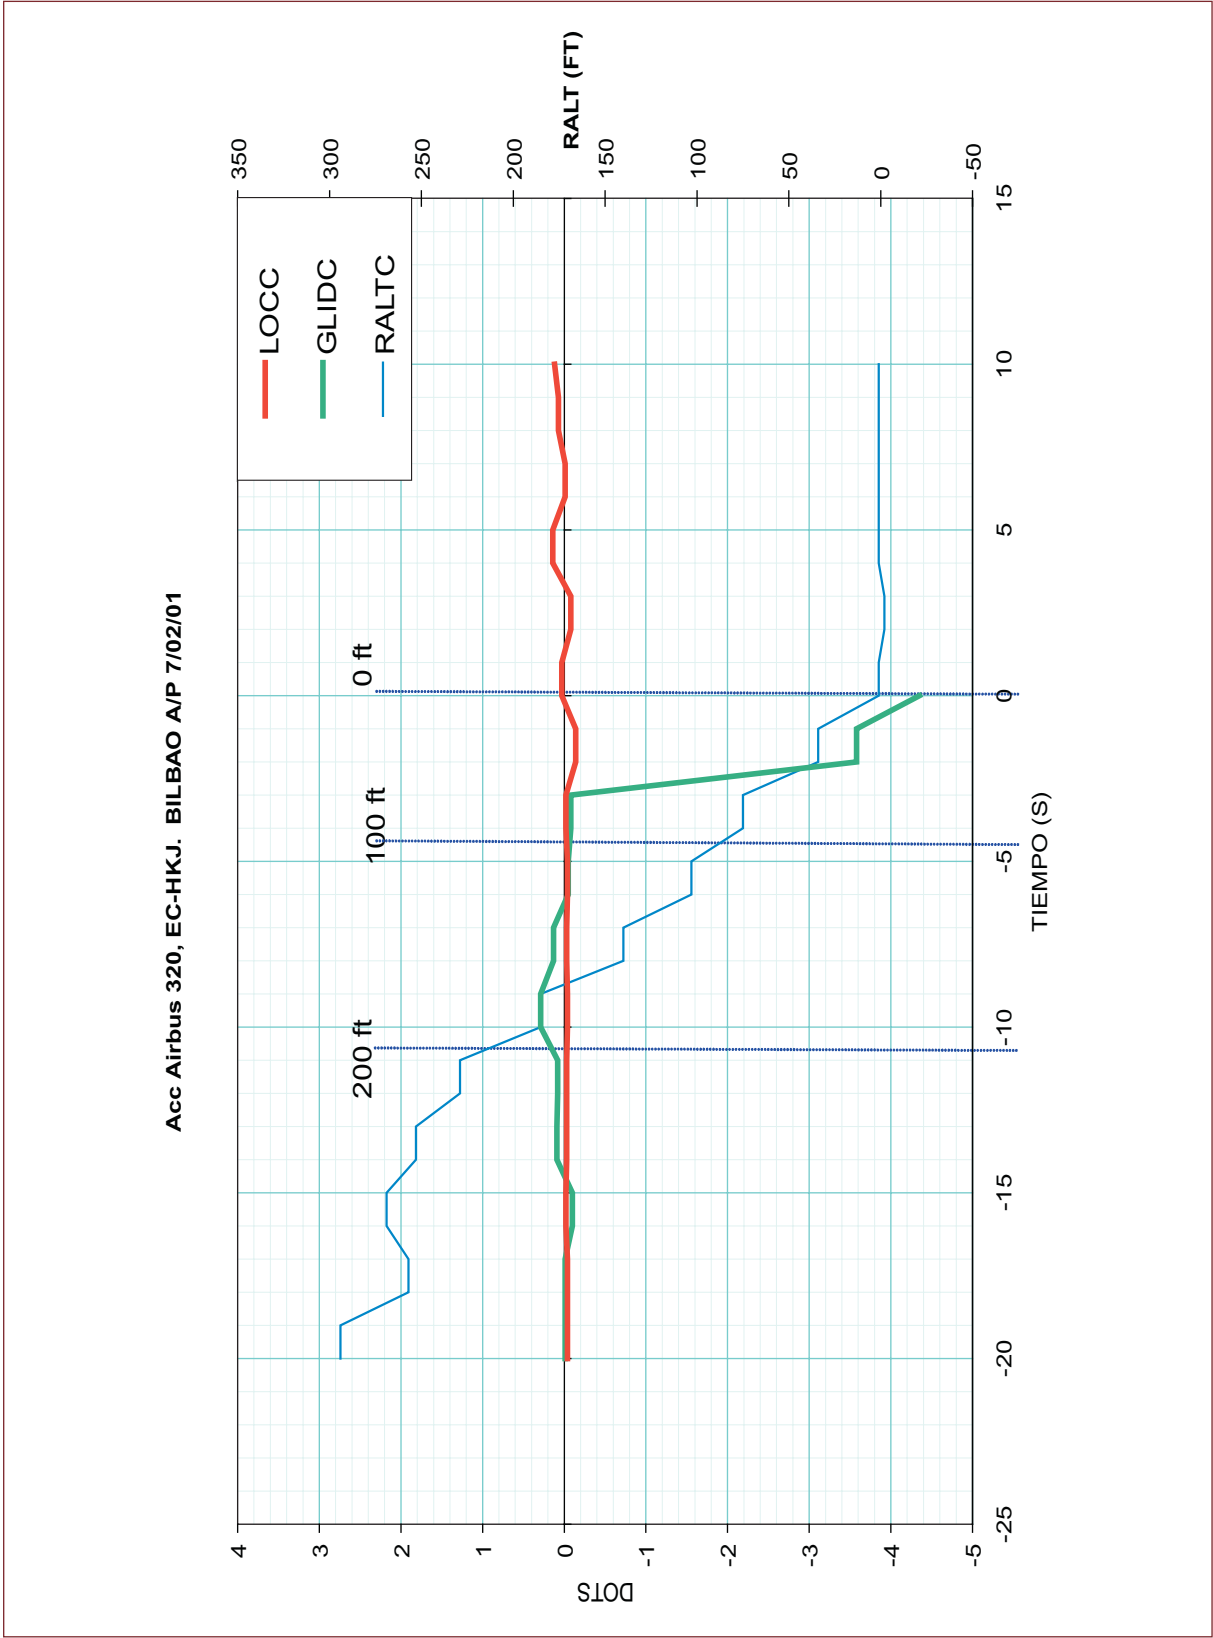
During its approach, aircraft A-320 flying under call-sign IB-1456 on 7 February 2001, found strong winds of 55 kt at around 6,000 ft of altitude. Strong movements and over-speed warnings alerted the crew of the turbulence and windshear conditions that could also have been expected from the TAF issued by the meteorological services, although the METAR and the TWR information only informed of wind intensity from 8 to 12 kt. The crew managed to get an acceptable reading of the glideslope (see graphs 3 and 4 in Appendix A).

Figure 3. ILS deviations

Figura 4. ILS deviations (continued)

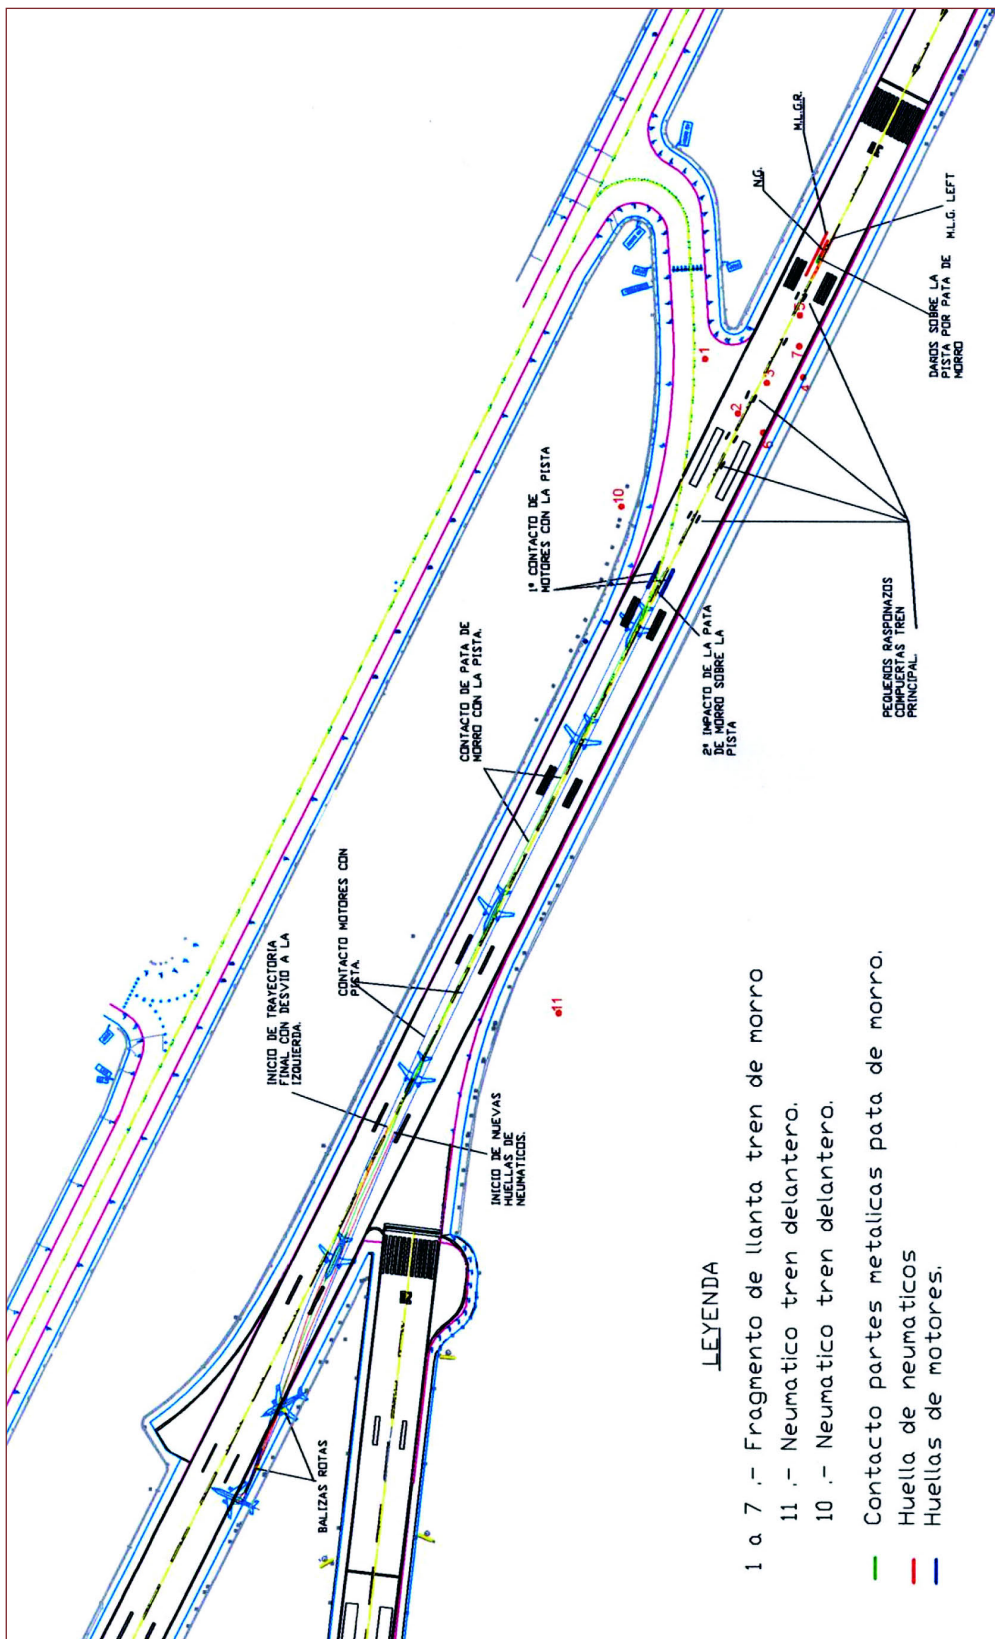
The tire tracks observed on the runway begin 130 m downward from the displaced runway 30 threshold. The tracks correlate to the two legs of the main landing gear, centered on the runway, with the left gear track located upon the runway centerline.

Tracks from the engines and the nose gear continue until the final position of the aircraft when it came to a stop, some 1,100 m from the initial impact point. At the point where the trajectory veers to the left, some 500 m after the appearance of the engines marks, the tracks of the main gear tires are noted again, possibly due to the lateral slipping of the aircraft, whose tires might have blown after that moment. The marks continued up to the end of the trajectory of the aircraft (see Appendix B).

Figure 1. Drawing of Bilbao runway 32, runway marks and wreckage distribution
