WBA of the Royal Majesty Accident

Derived from NTSB Report NTSB/MAR-97/01

Lars Heidieker, Nils Hoffmann, Peter Husemann, Peter B. Ladkin,
Jan Paller, Jan Sanders, Jörn Stuphorn, Andreas Vangerow

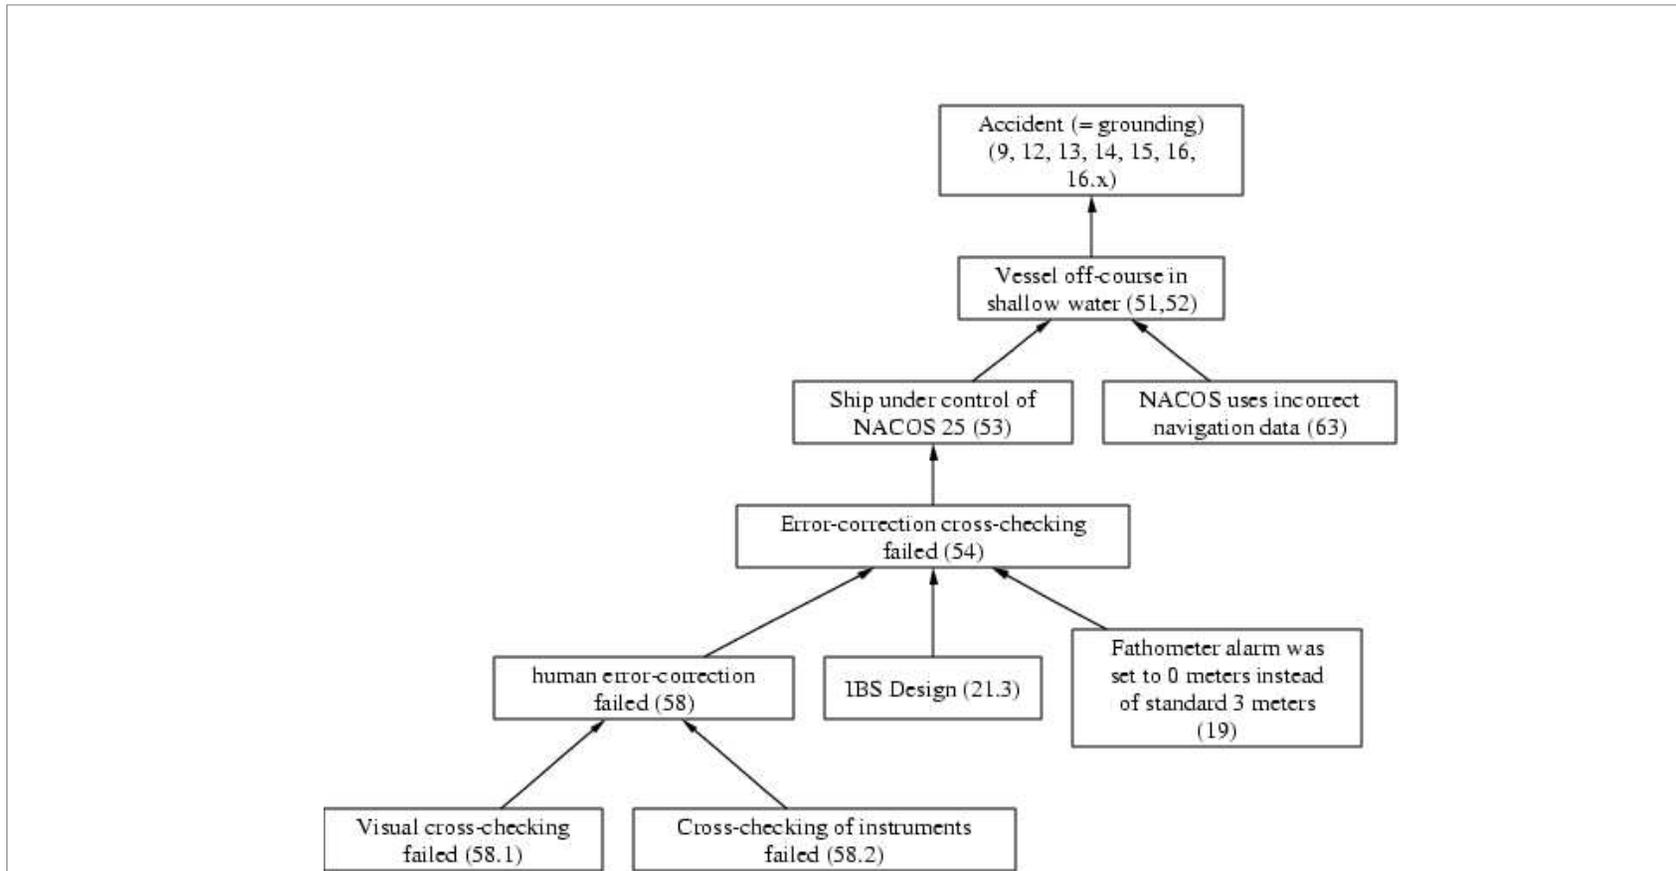
A WBG Reduction

- A reduction is a removal of nodes
 - In the reduction, edges represent paths in the original WBG
 - The reduced graph must partition the original WBG; that is, every causal path through the original WBG must pass through some node in the reduction
 - These „key nodes“ must be chosen somehow
- Do any of these reductions appear to be a plausible summary of the WBG?
- If so, how, formally, is the reduction generated?

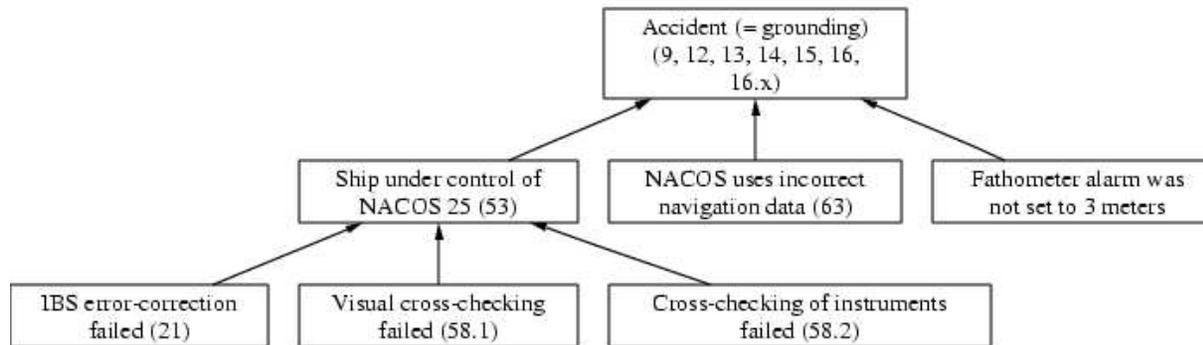
The WBG Reduction with „Negative“ FathAlarm

- That the inappropriate functionality of the fathometer alarm was a causal factor in the grounding is determined directly through the Counterfactual Test
 - Had the alarm been set to 3m, warning would have been given in adequate time to take evasive action
- However, this is not the assertion concerning the fathometer alarm that appears in the report body or Conclusions
 - It appears their positively: it was set to 0m
- Positive and negative formulations of the same „fact“ have different causal relations!
