GABINETE DE PREVENÇÃO E INVESTIGAÇÃO DE ACIDENTES COM AERONAVES

Accident Investigation Final Report

All Engines-out Landing Due to Fuel Exhaustion

**Air Transat
Airbus A330-243 marks C-GITS
Lajes, Azores, Portugal
24 August 2001**

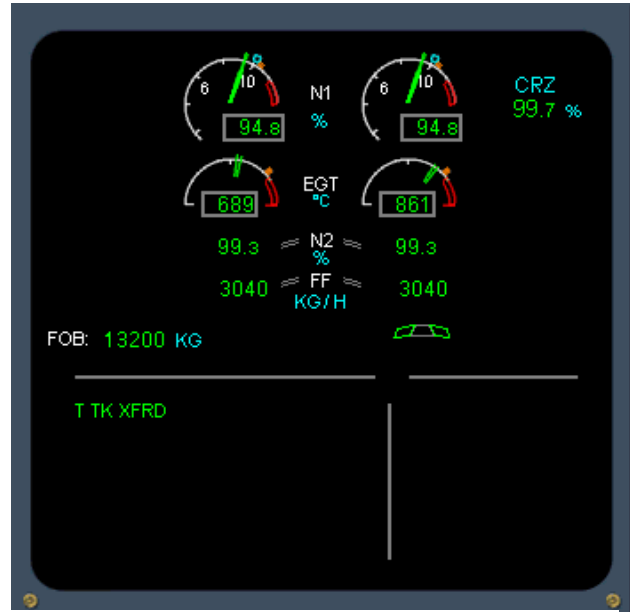
A trim tank is located in the THS. The trim tank transfer system is a fully automatic mode system that controls the center of gravity of the aircraft. When the aircraft is in cruise, the primary Fuel Control and Management Computer (FCMC) calculates the C of G and compares the result to a target value that depends on the aircraft actual weight. From this calculation, the FCMC optimizes the C of G by deciding to transfer fuel to or from the trim tank. There is normally only one aft transfer at the beginning of the flight. During the flight, there is a series of small forward transfers. If the actual C of G is different from the target C of G by more than 0.5% and the aircraft is above Flight Level 255, an appropriate transfer occurs. If an inner tank quantity drops below 4 000 kg, forward transfer also occurs to maintain the fuel in the inner tanks between 4 000 kg and 5 000 kg until the trim tank is empty. If during a forward transfer the inner tanks are out of balance by more than 500 kg, the transfer is automatically stopped on the heaviest side until the fuel balance is achieved. A final forward transfer occurs when the time to destination is less than 35 minutes, when either set of wing tanks is below 4.0 tons, or when the aircraft descends through FL245. When fuel is being transferred, a “TRIM TANK XFR” message appears on the ECAM Memo screen; when the trim tank is empty, a “TRIM TANK XFRD” message appears on the ECAM Memo portion of the E/WD screen.

Figure 5 - E/WD & Trim Tank Transferred Memo
