Technical report A-006/2001

Accident of aircraft Airbus
A-320-214, registration
EC-HKJ, at Bilbao Airport
on 7 February 2001

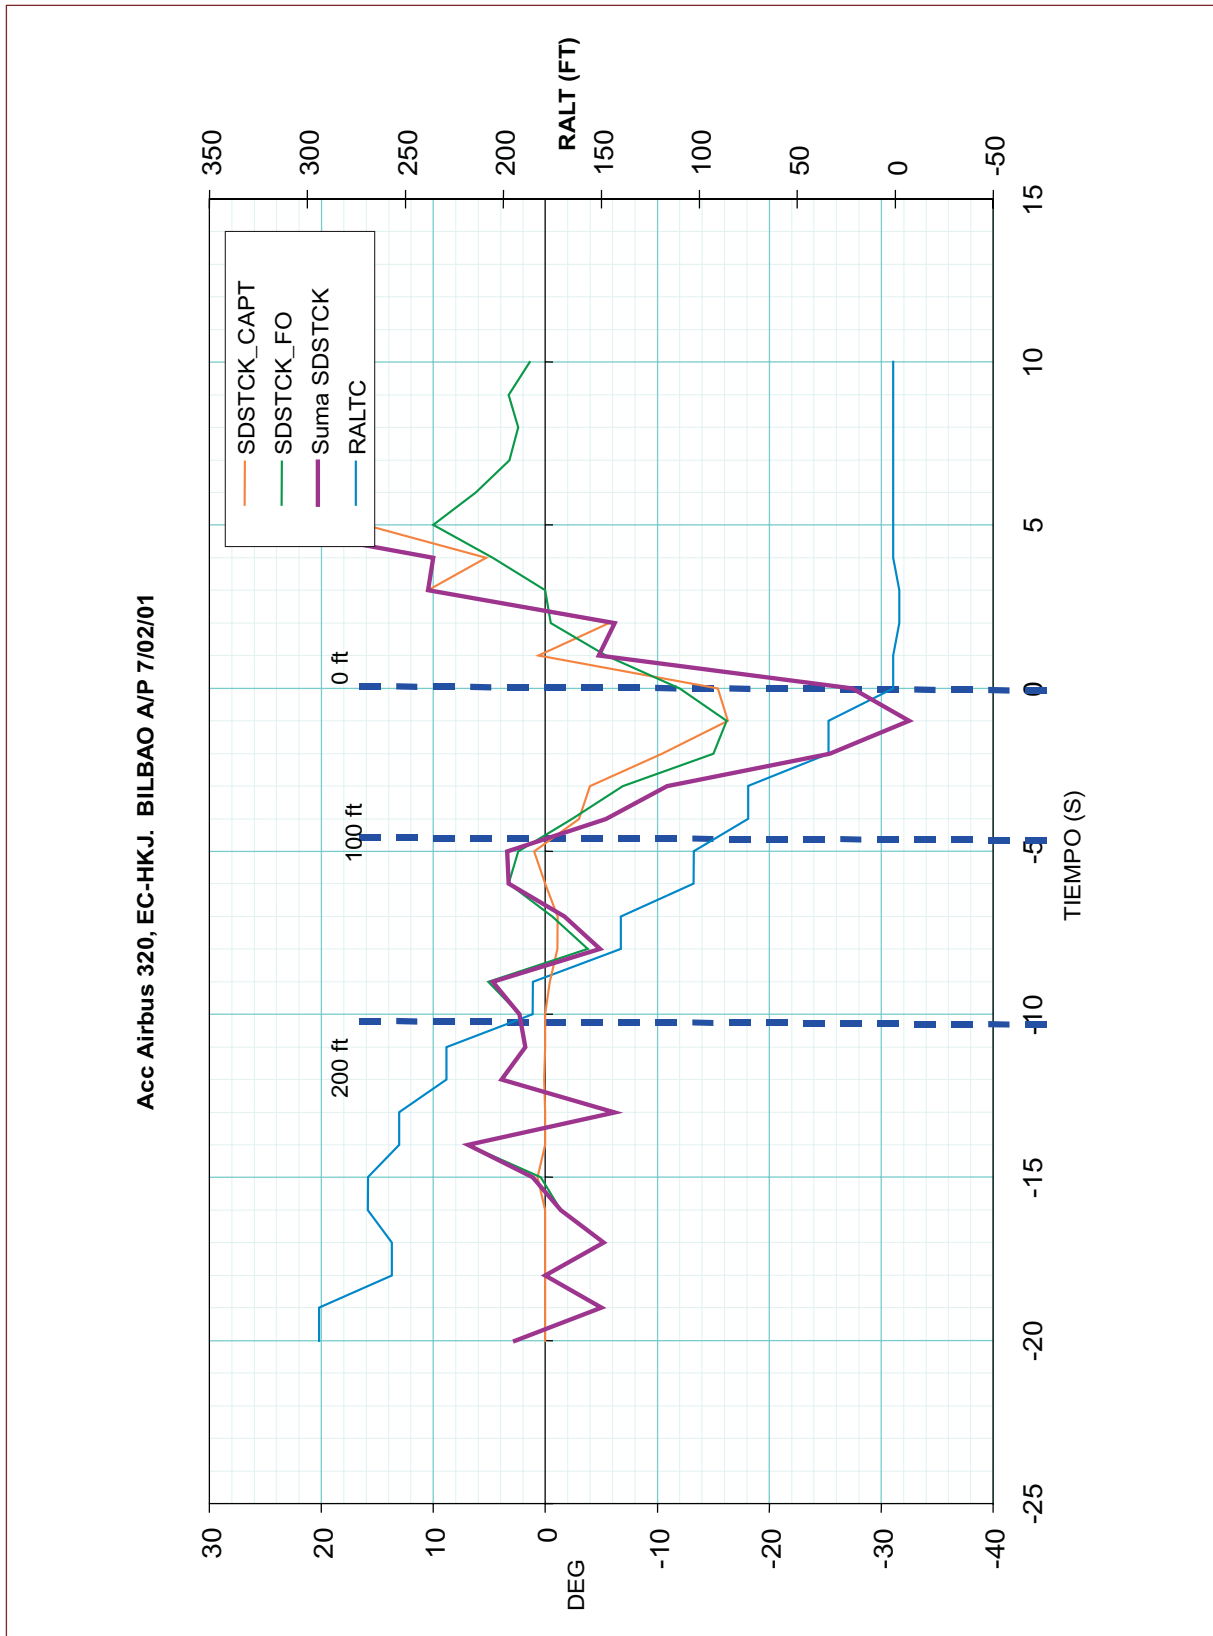
Figure 7. *Actions of the pilots on the sidesticks*

When the aircraft found the updraft, the pilot flying pushed his sidestick, and afterwards he pulled it when he entered the down-draft.

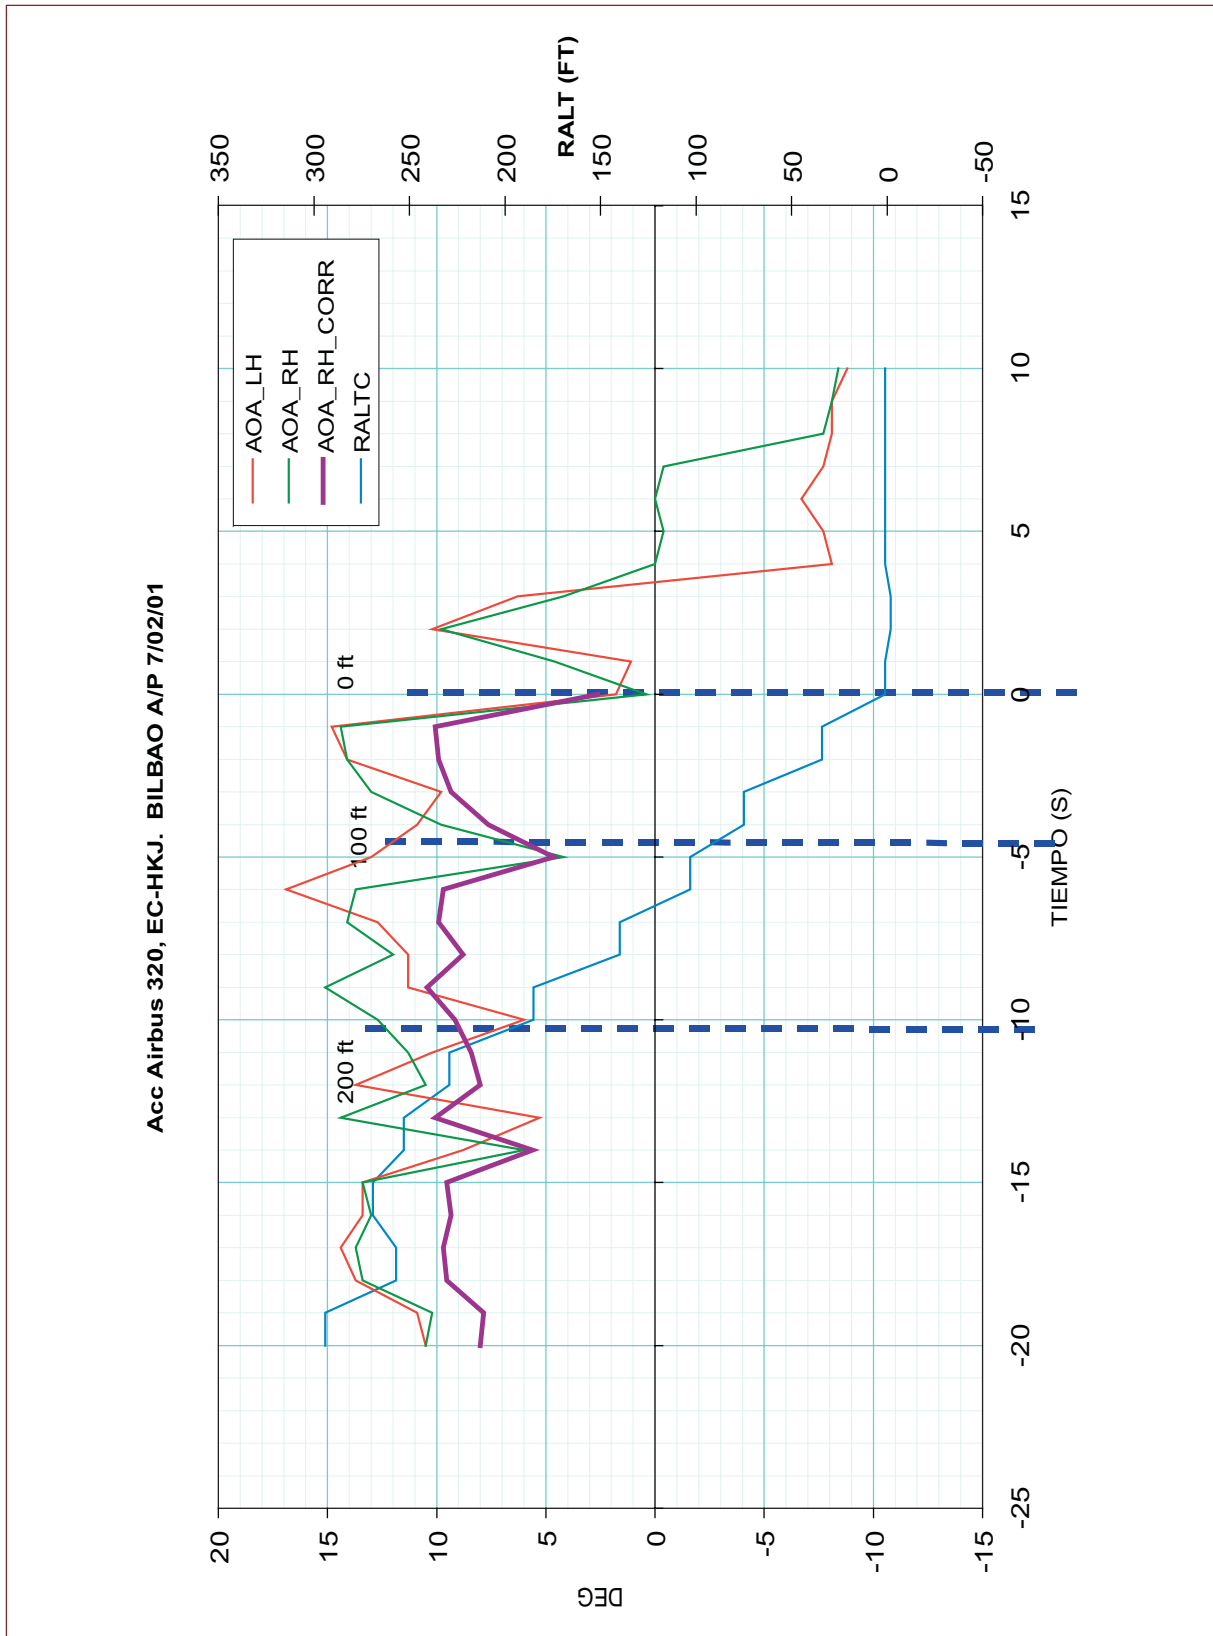
Figure 9. Angle of attack records and estimate of the corrected angle of attack

The vertical gusts caused very fast AOA increments. The ELAC L80 software included an anticipation factor or «phase advance» as a function of the rate of increase of the AOA. This factor was responsible, in this case, for the activation of the AOA protection. This was further confirmed because in simulations done with previous standards to ELAC L80, which do not have that anticipation factor, it was not possible to reproduce the accident aircraft behavior.

Airbus Industrie developed a new standard for the ELAC, standard L81, to modify the logic in the AOA protection in case of turbulent conditions. The new standard was certified by mid 2001, and the corresponding Service Bulletin was published in September 2001. The software modification, considered mandatory by the aeronautical

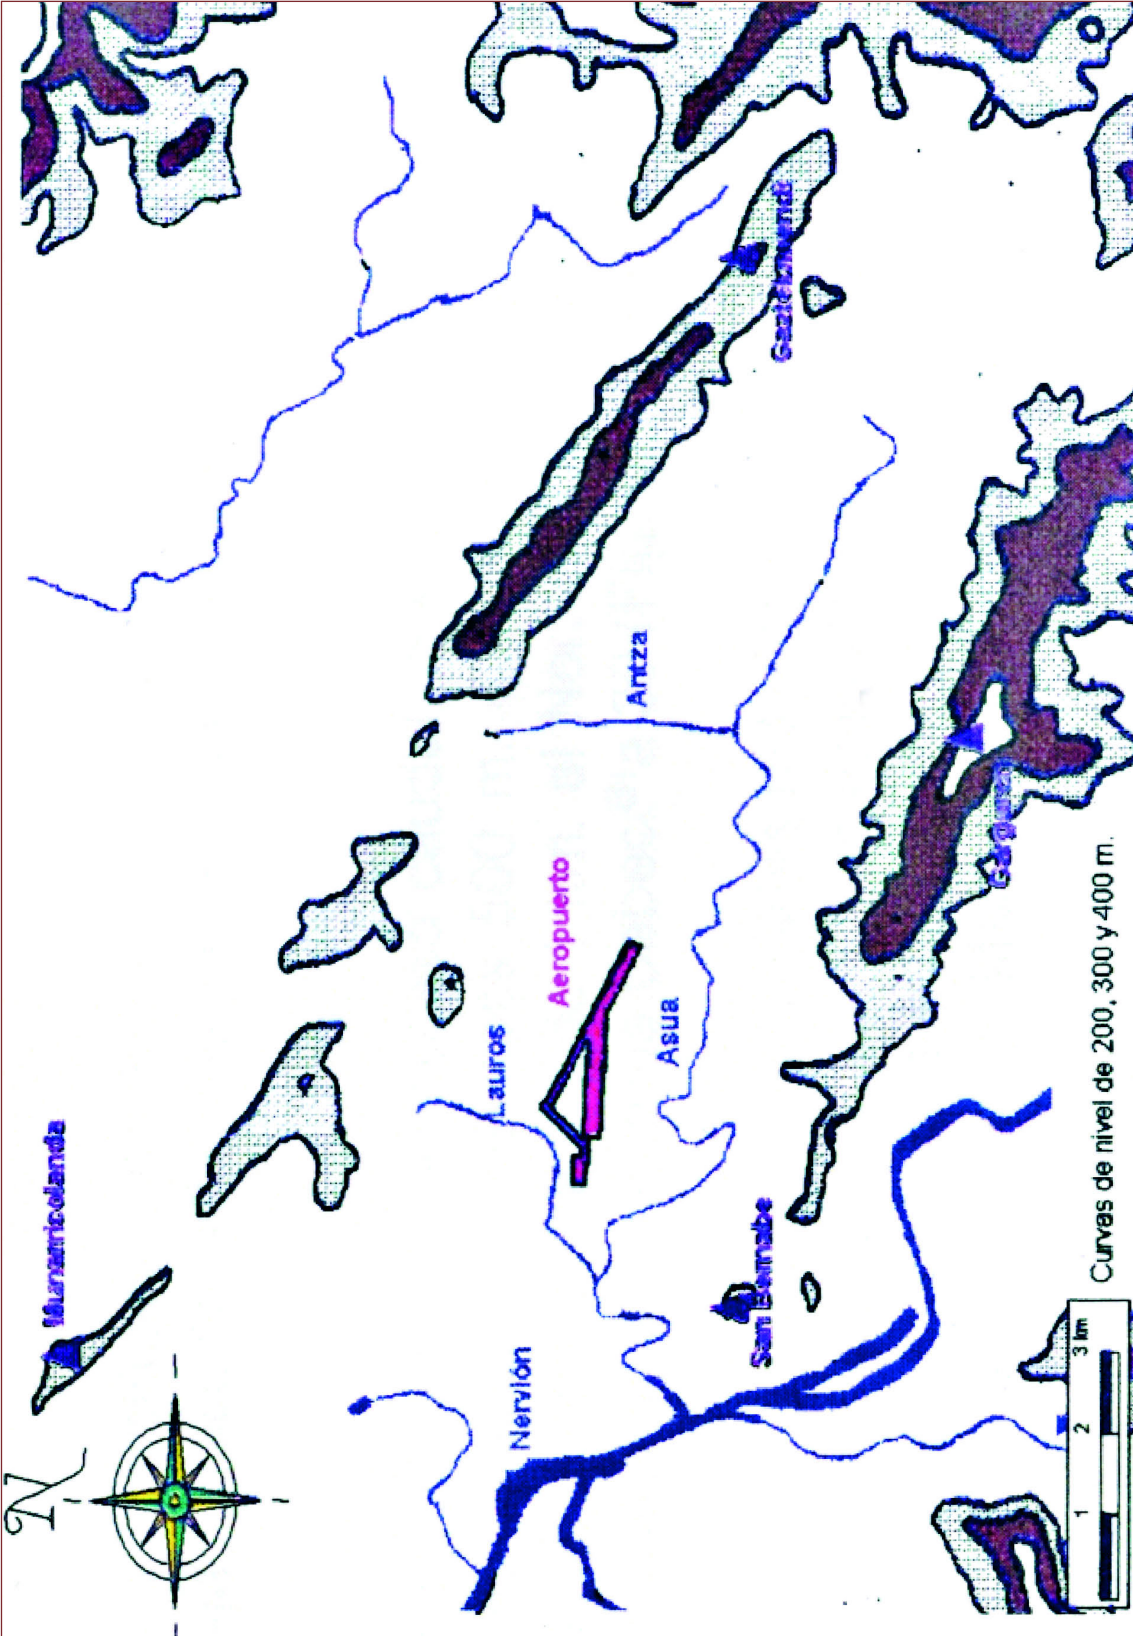
Figure 2. Drawing of the mountain area around Bilbao Airport

With south and southwest winds there is often turbulence surrounding Bilbao airport, from ground level to 5,000 ft, which can become severe.
